**INFRARED BUILDING ENVELOPE SURVEY**

*ABC Company  
123 Main Street  
Anytown, USA*

RE: INFRARED BUILDING ENVELOPE SURVEY REPORT  
OUR JOB NUMBER: 16-1234.5

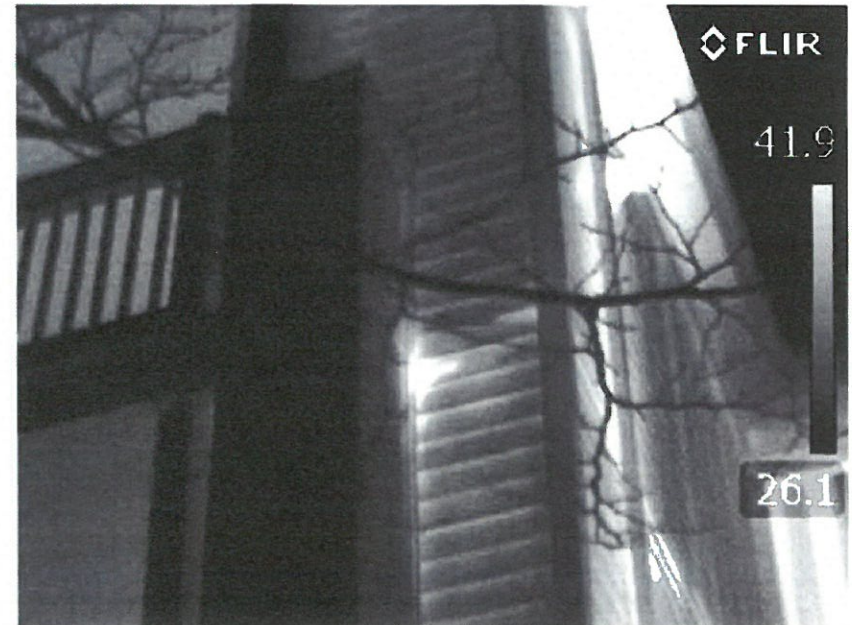
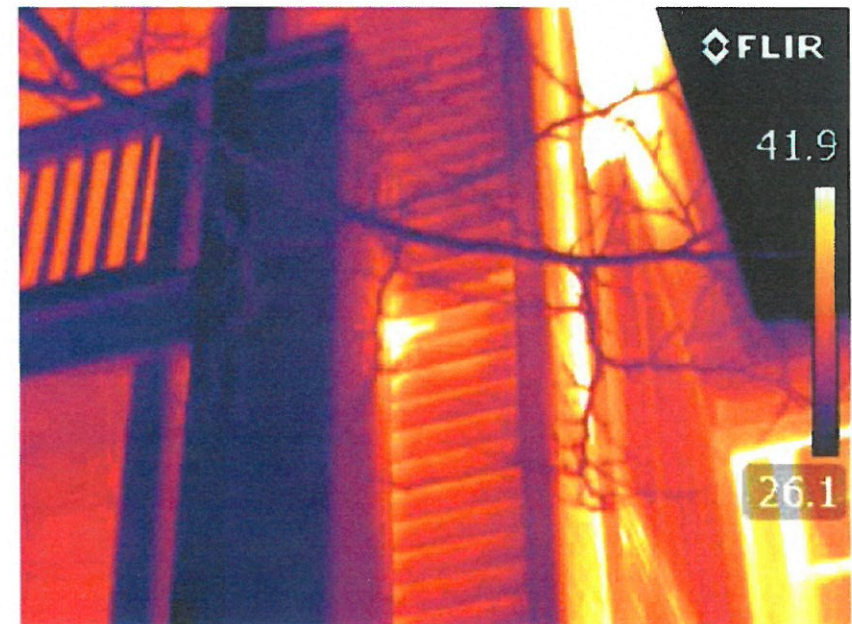
Area/Picture No. 15 Job No. 16-1442.11 Date 3/3/16

Comments Thermogram shows warm anomaly (white) at the seam to the right of 3rd floor balcony.

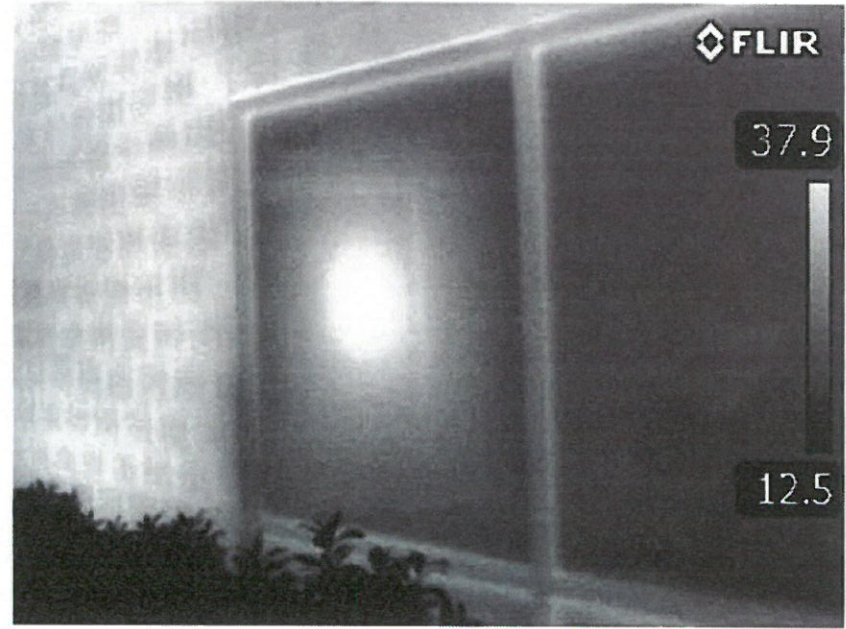
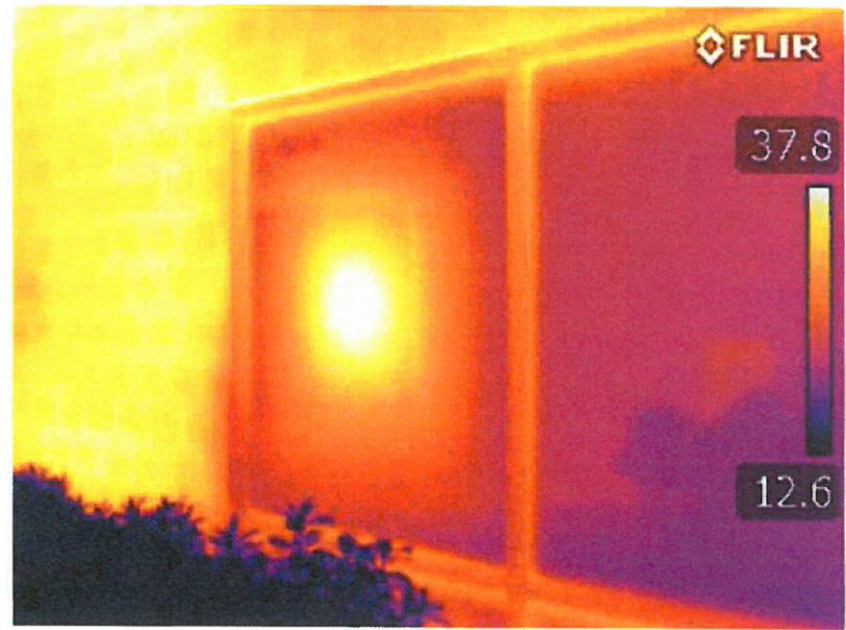
Area/Picture No. 26 Job No. 14-3062.1A Date 1/8/15  
Location Child Care  
Equipment Section F, Left Window  
Wind Speed N/A Wind From N/A Sky Partly Cloudy  
Emiss. 1.00 B/G N/A° Distance 30' Lens 1x  
Ambient Temp 17°F  
Comments Thermogram shows thermal pattern typical of failed IGU for left window.

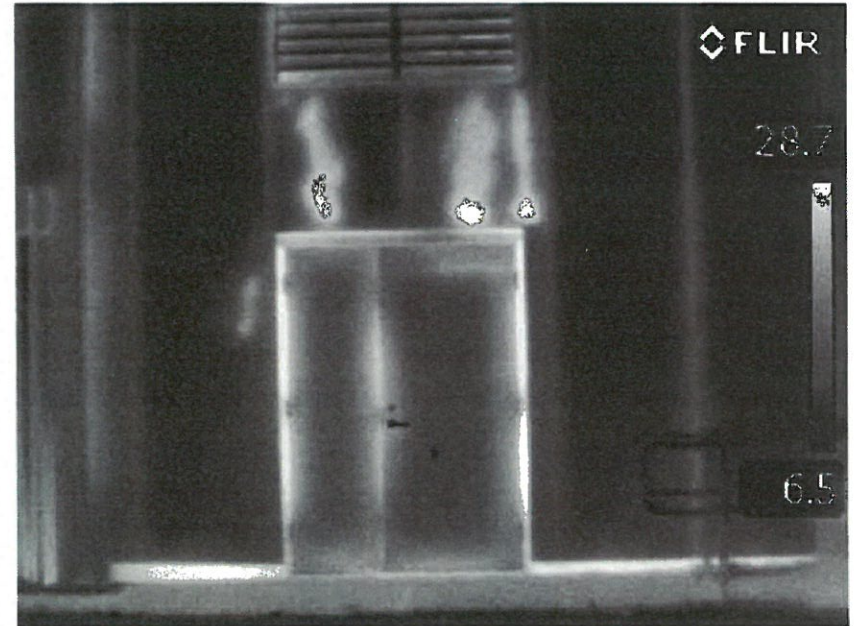
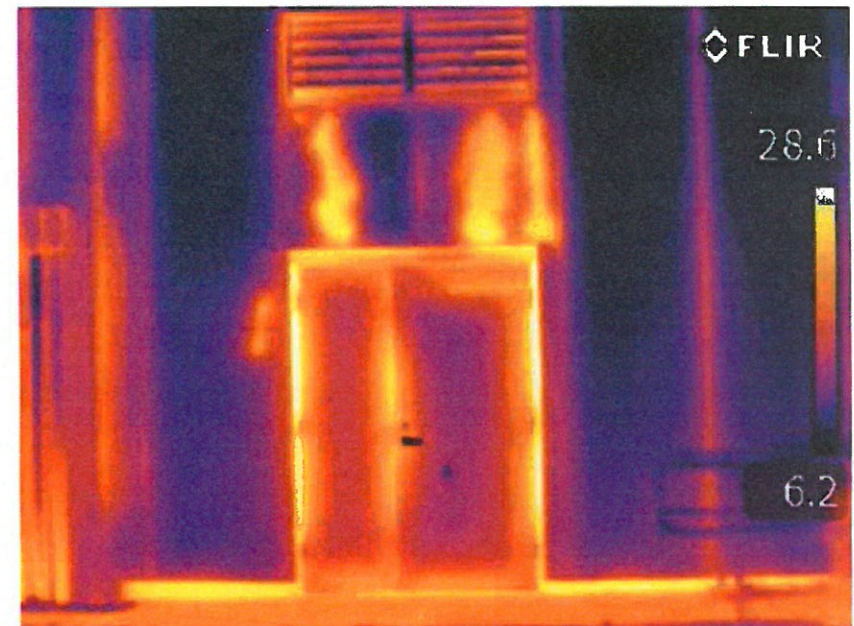
**Comments** Thermogram shows middle door with energy loss around door. Also, possible moisture above the door.

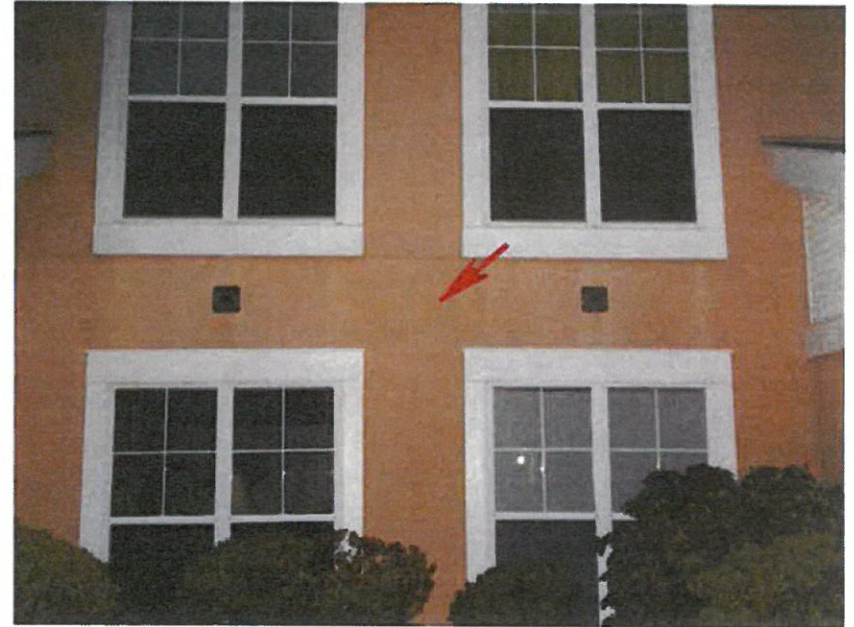
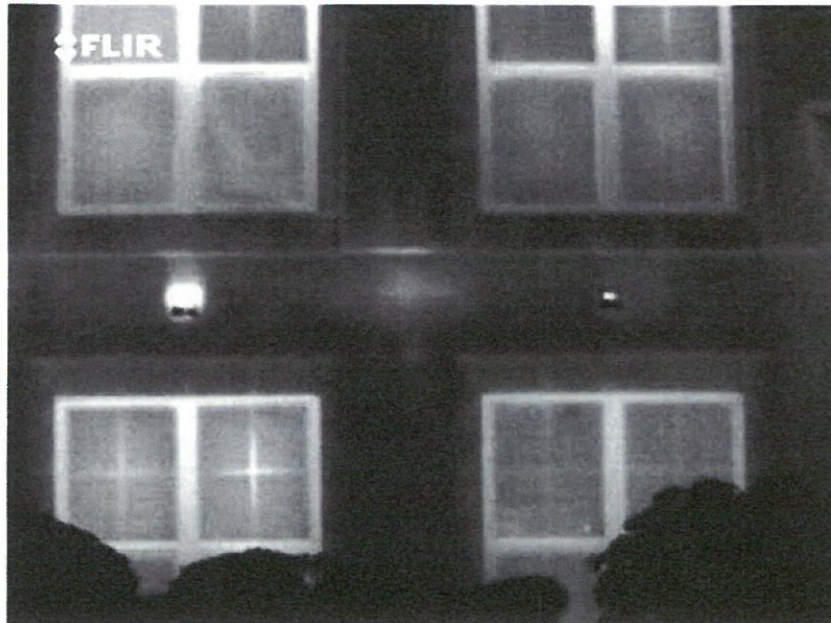
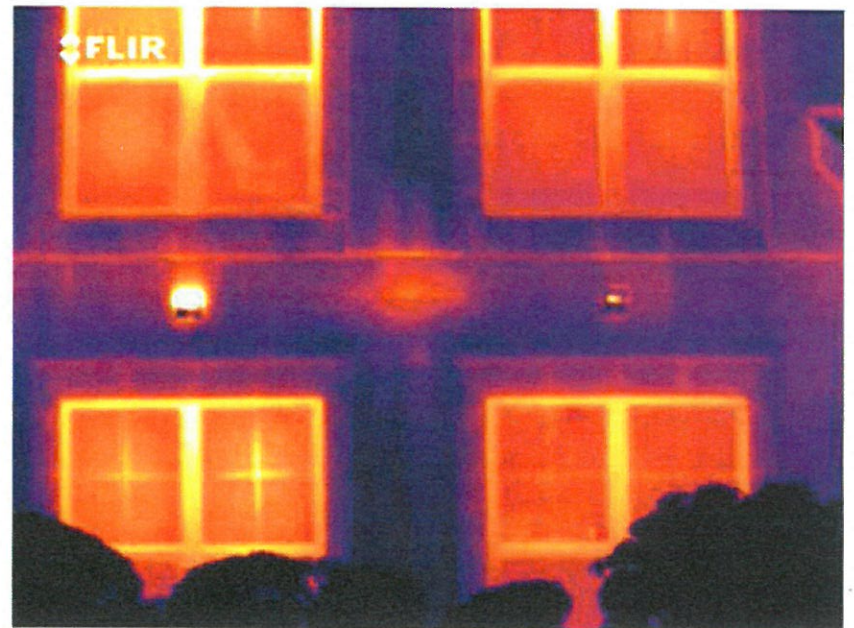
Area/Picture No. 4 Job No. 16-1442.11 Date 3/3/16

Comments Thermogram shows warm area (orange) above and between 1st floor windows.

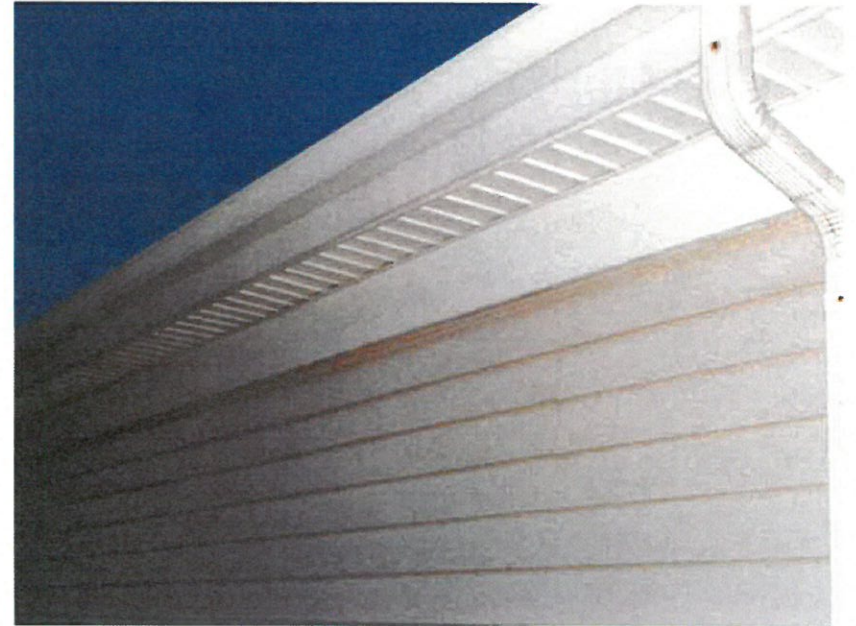
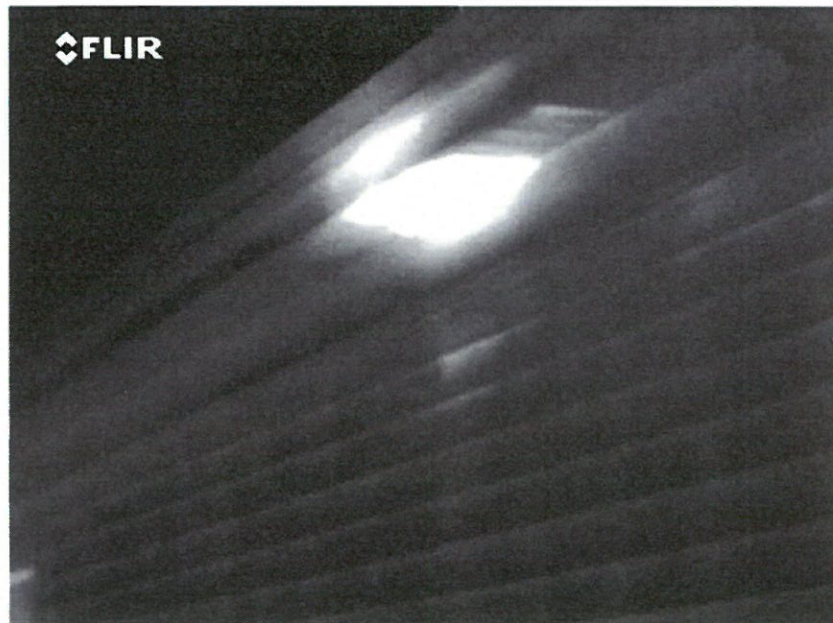
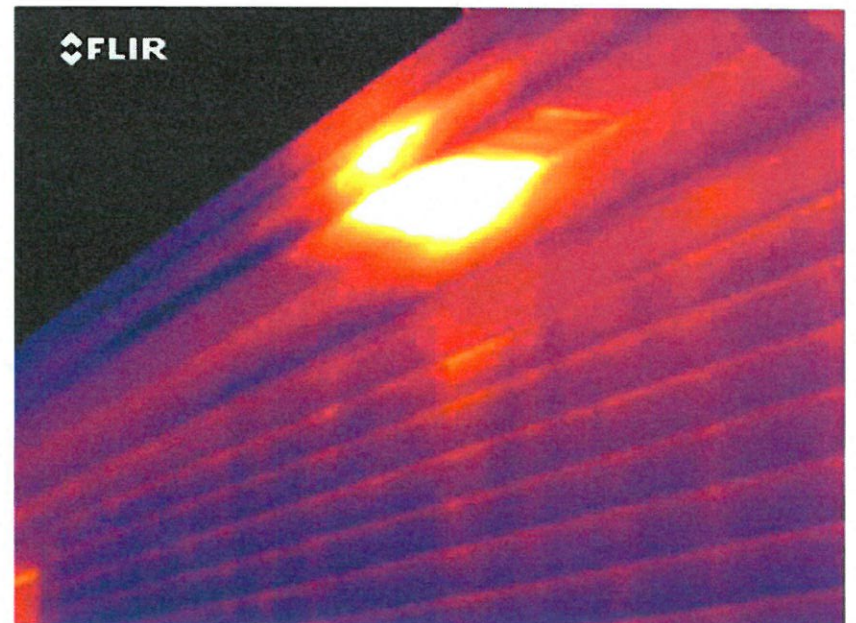
Area/Picture No. 2 Job No. 16-1442.11 Date 3/3/16

Comments Thermogram shows warm thermal pattern (white) in the soffit area approximately 8 ft. from right corner of building.

White area is approximately 34°F warmer than the adjacent area.

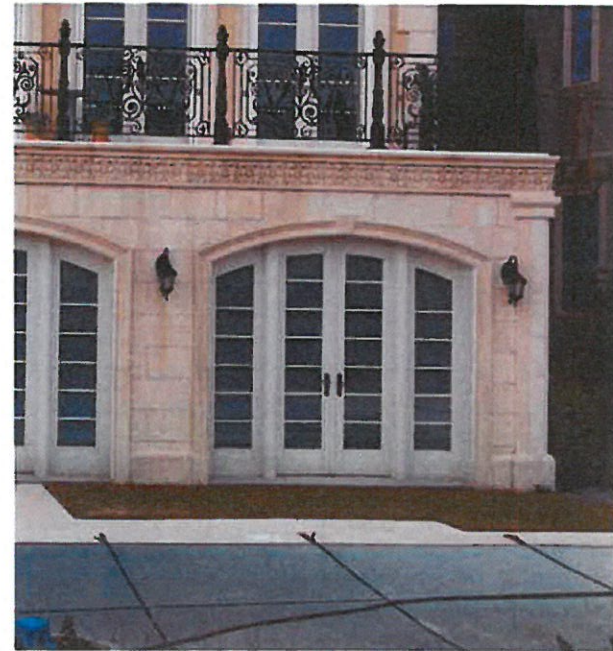
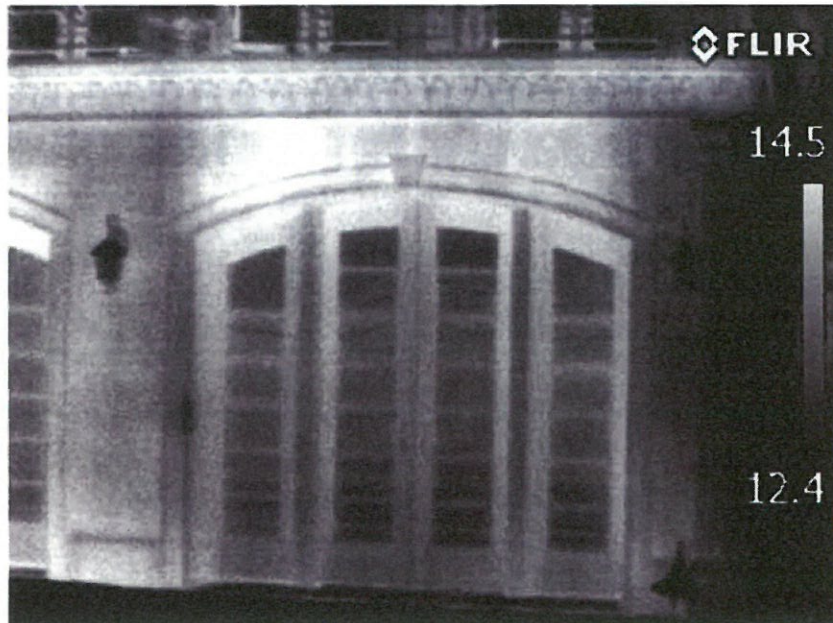
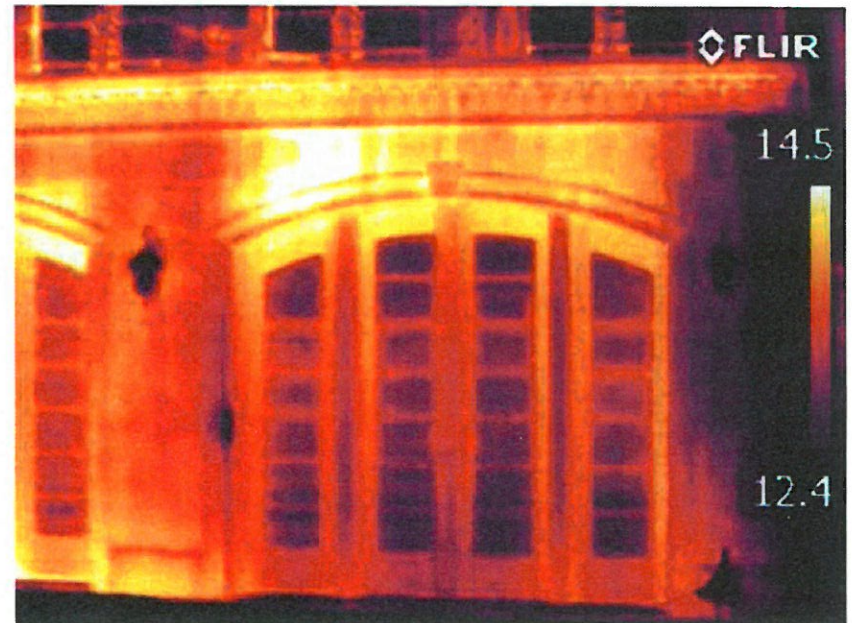
Area/Picture No. 16 Job No. 16-3161.1 Date 3/17/16

Comments Thermogram shows warm thermal pattern typical of subsurface moisture above and around right doors.

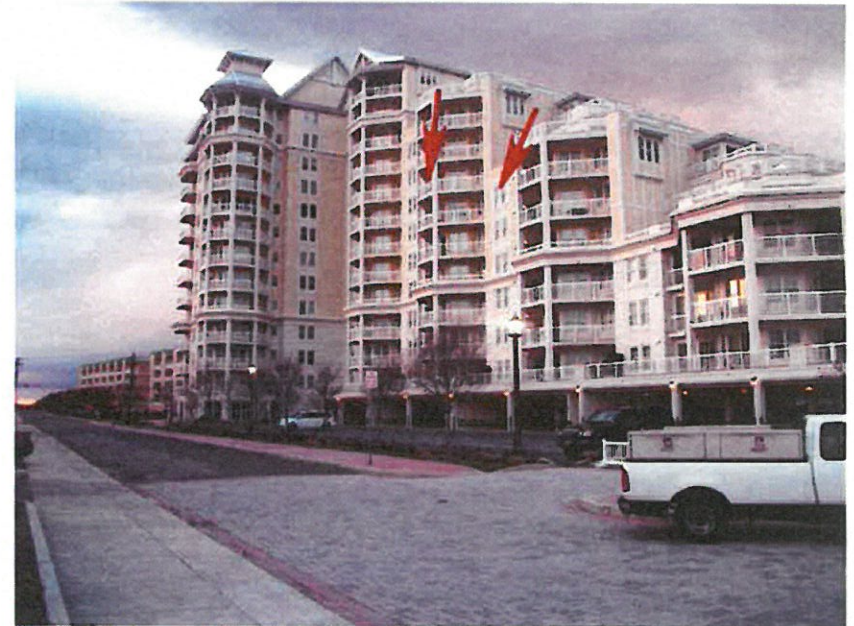
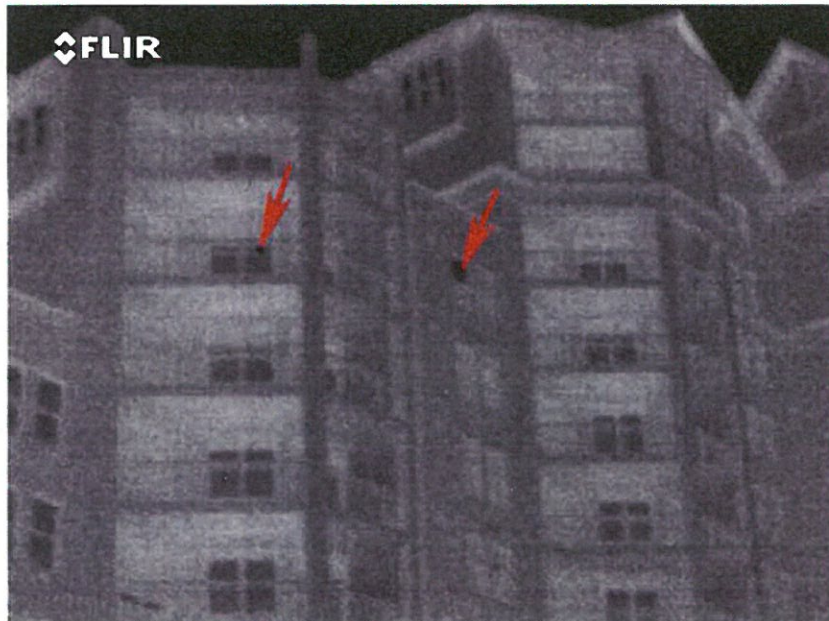
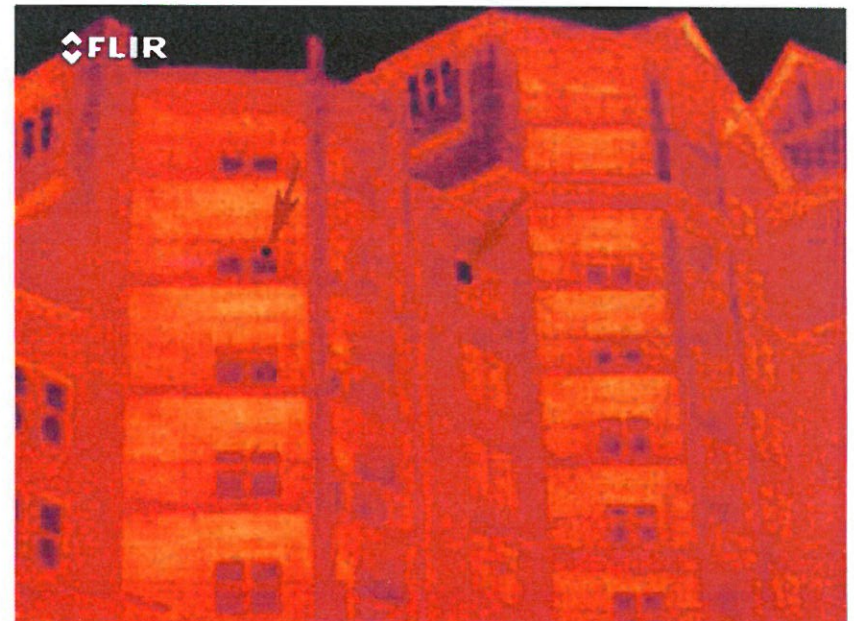
Area/Picture No. 5 Job No. 16-3149.2 Date 3/17/16

Comments Thermogram exhibits black spots on two windows. Possible lost seals. Balance of walls and windows exhibit normal thermal pattern.

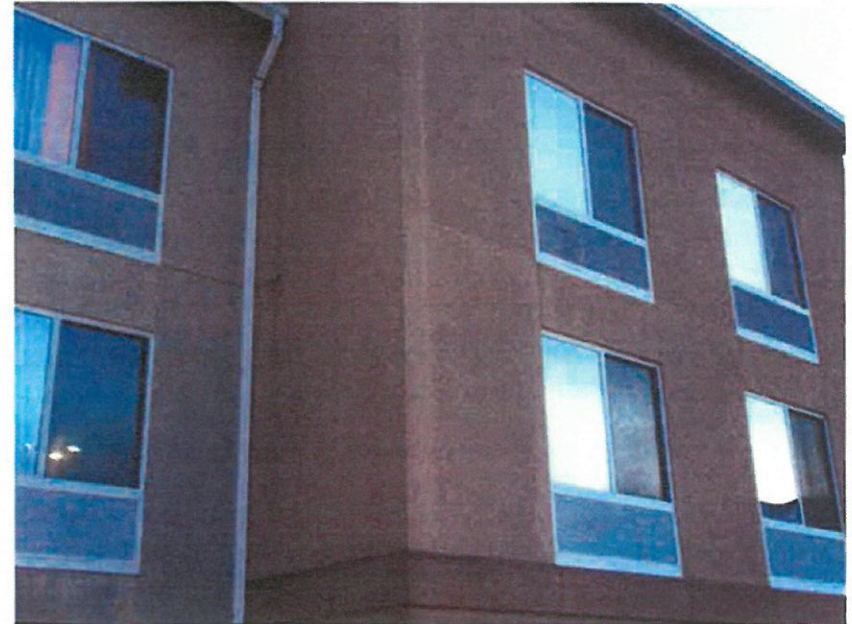
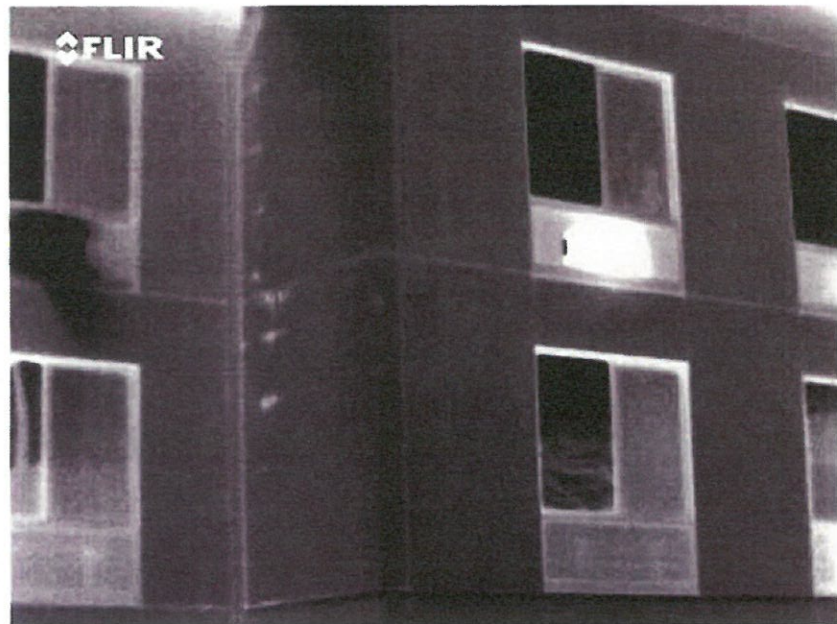
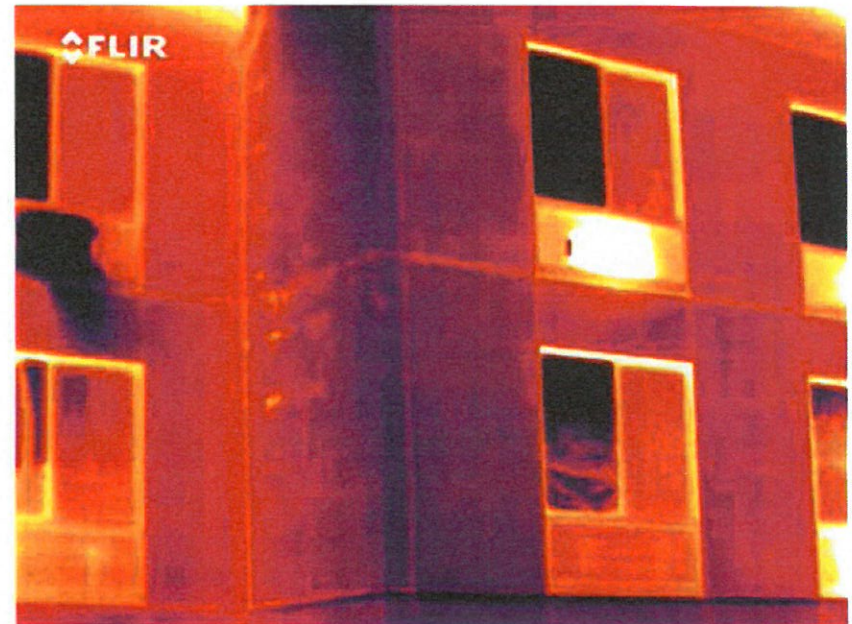
**Comments** Thermogram shows thermal anomalies typical of latent moisture in East wall of Rooms 207 and 307.

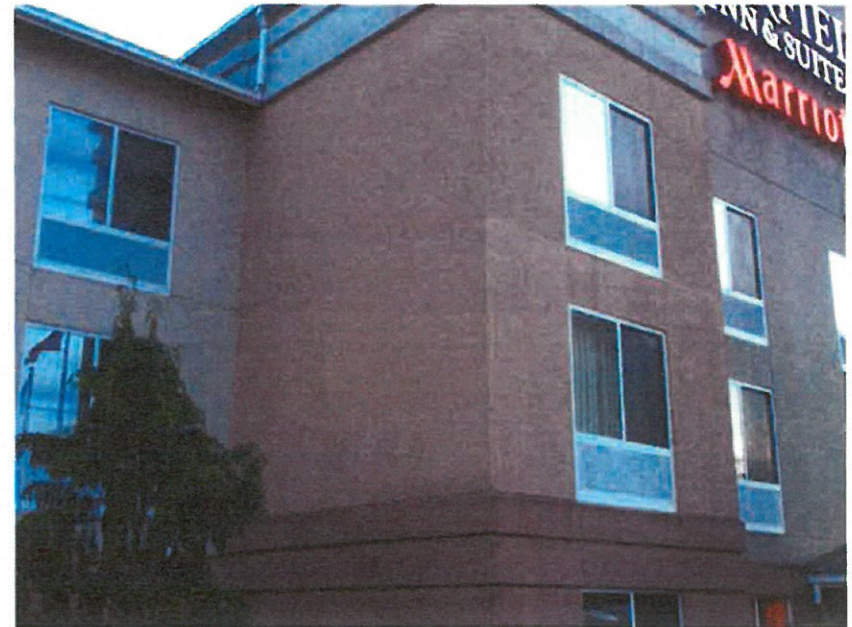
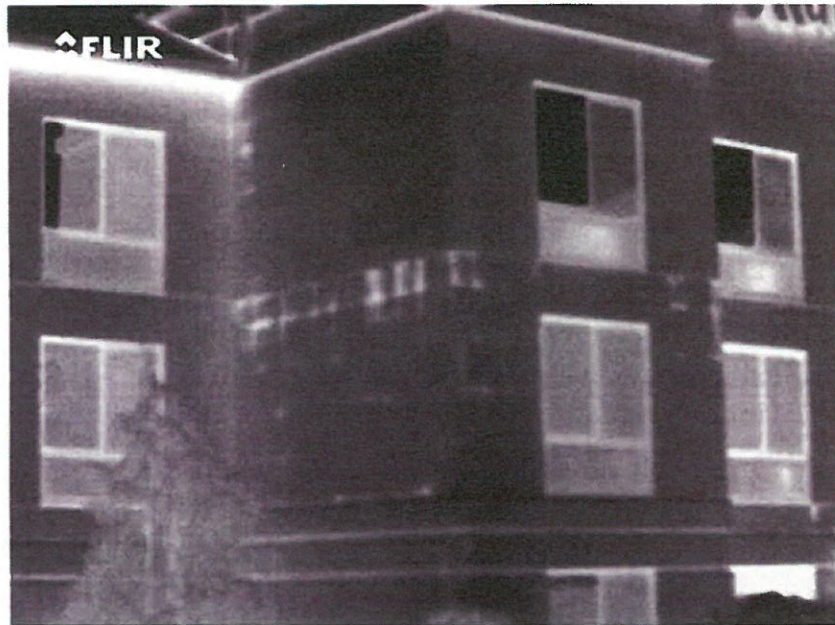
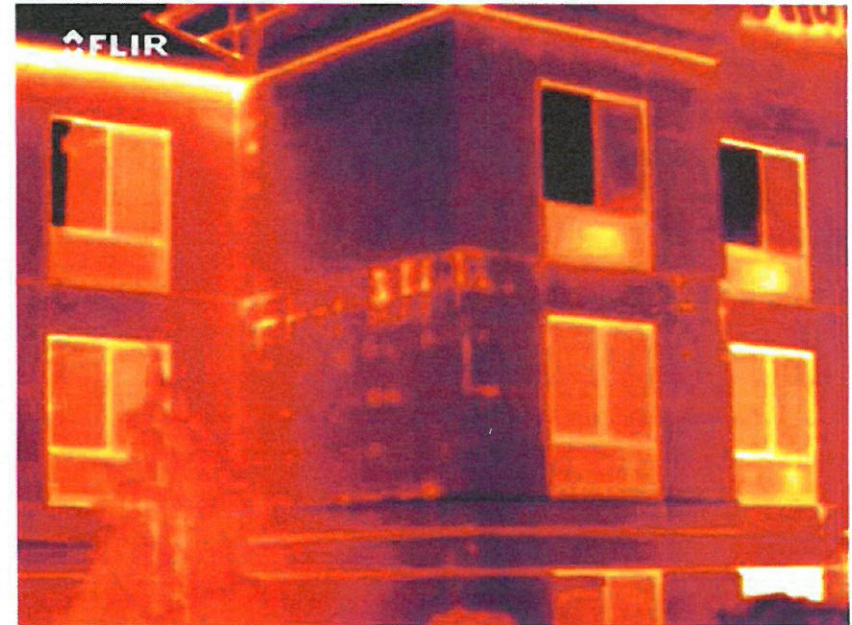
Comments Thermogram shows thermal anomalies typical of latent moisture in the North and East walls for Rooms 217 and 317.

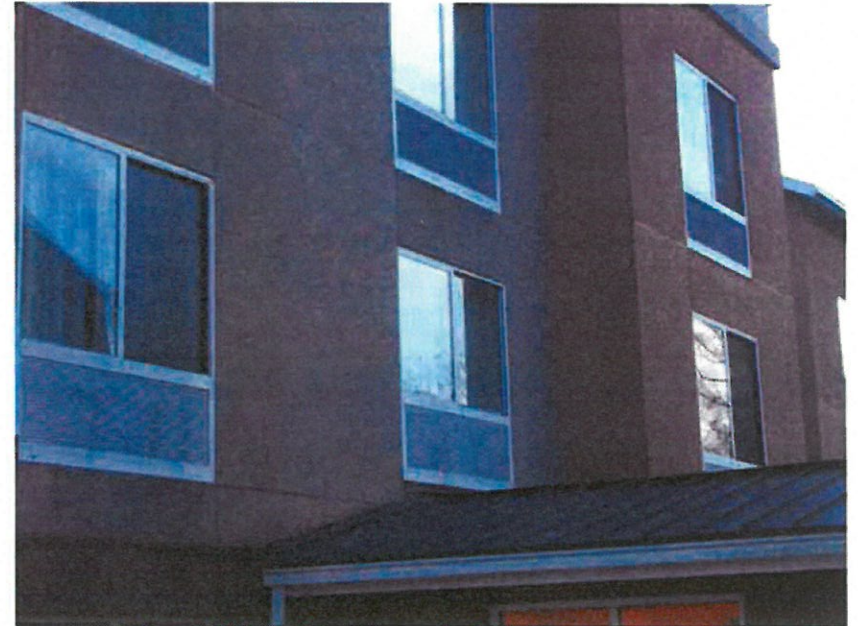
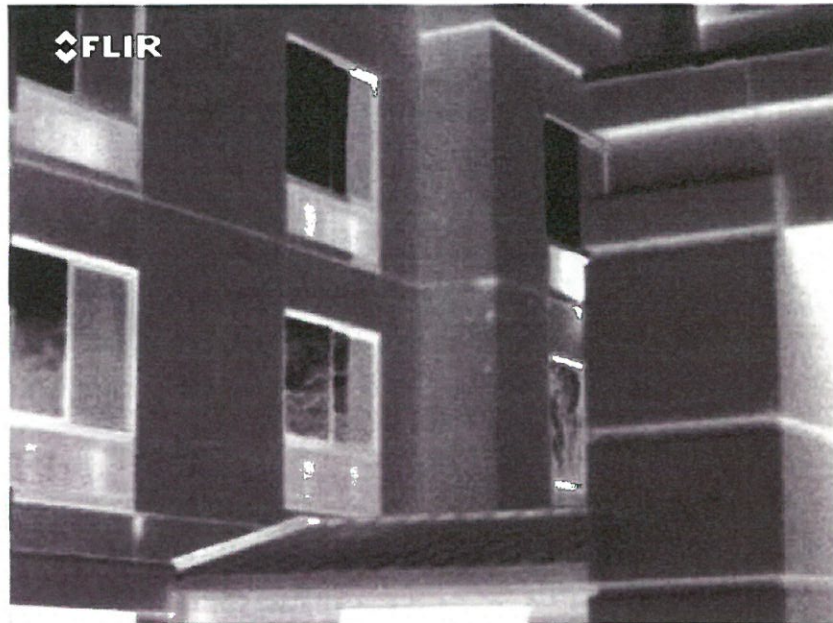
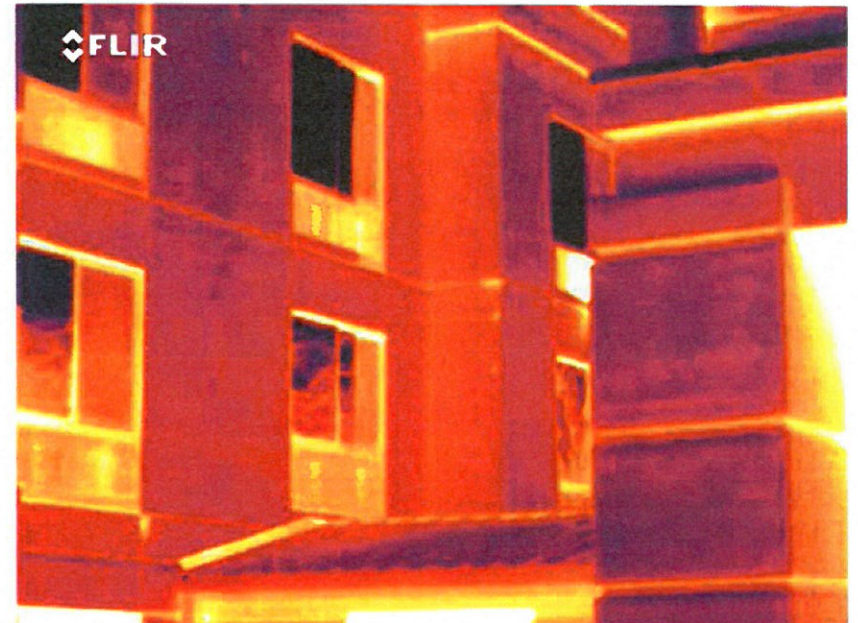
**Comments** Thermogram shows thermal anomalies typical of latent moisture in East Wall of Room 223 and at lower right corner of window for Room 219.

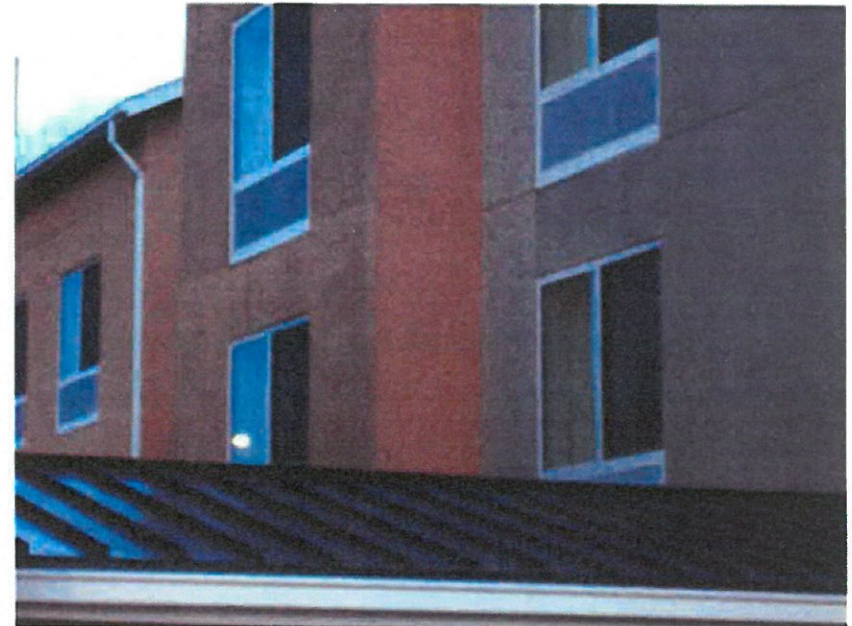
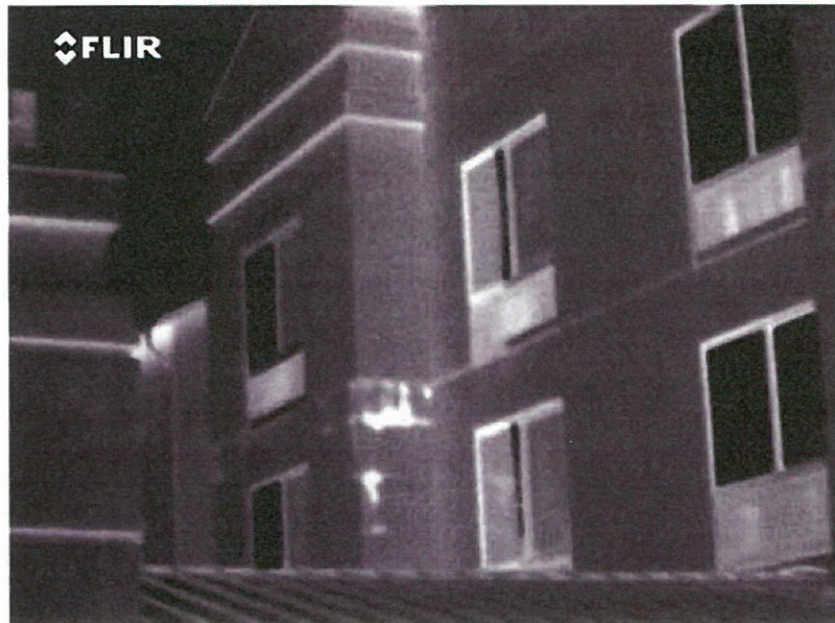
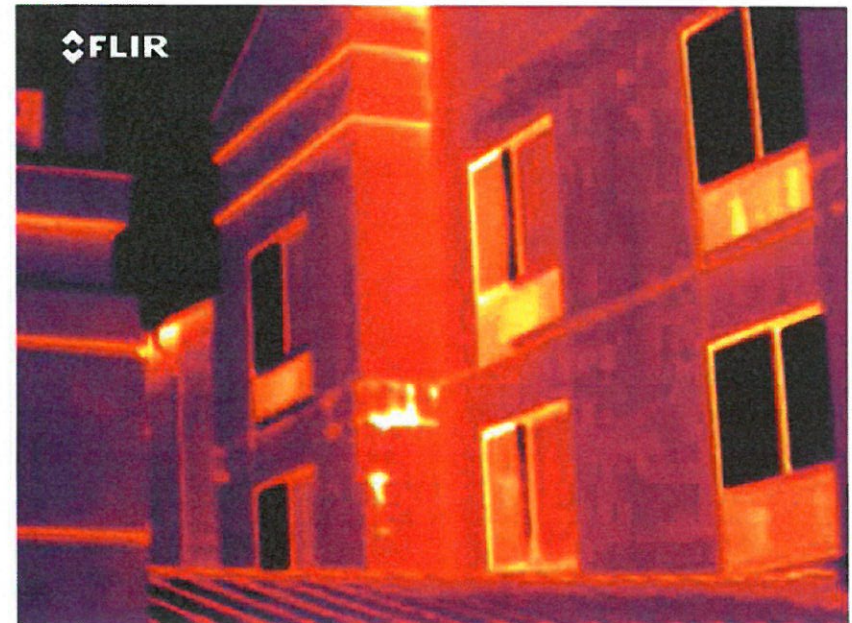
**Comments** Thermogram shows thermal anomalies typical of latent moisture for West and North walls of Room 217.
