**INFRARED BUILDING ENVELOPE SURVEY
(INTERIOR)**

*ABC Company
123 Main Street
Anytown, USA*

RE: INFRARED BUILDING ENVELOPE SURVEY REPORT
OUR JOB NUMBER: 16-1234.5

THERMOGRAPHER'S COMMENTS
OUR JOB NUMBER: 16-1234.5

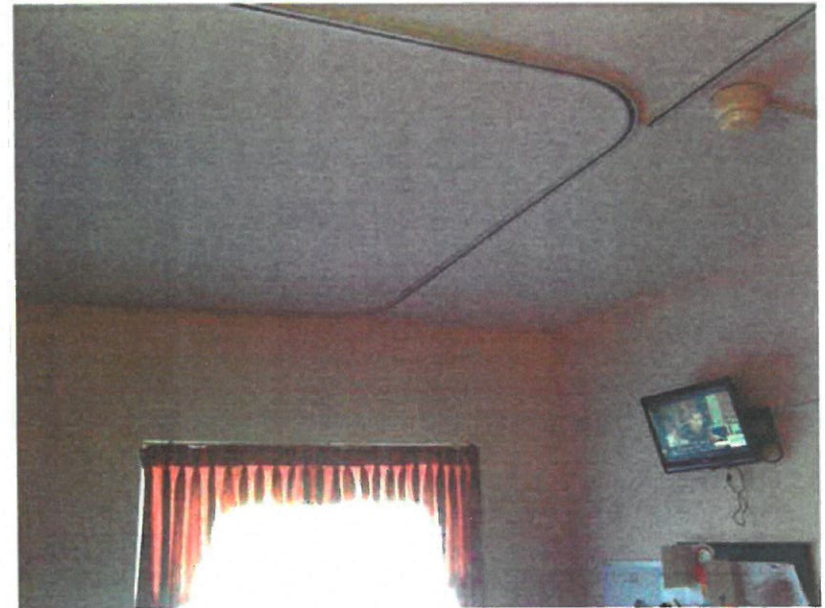
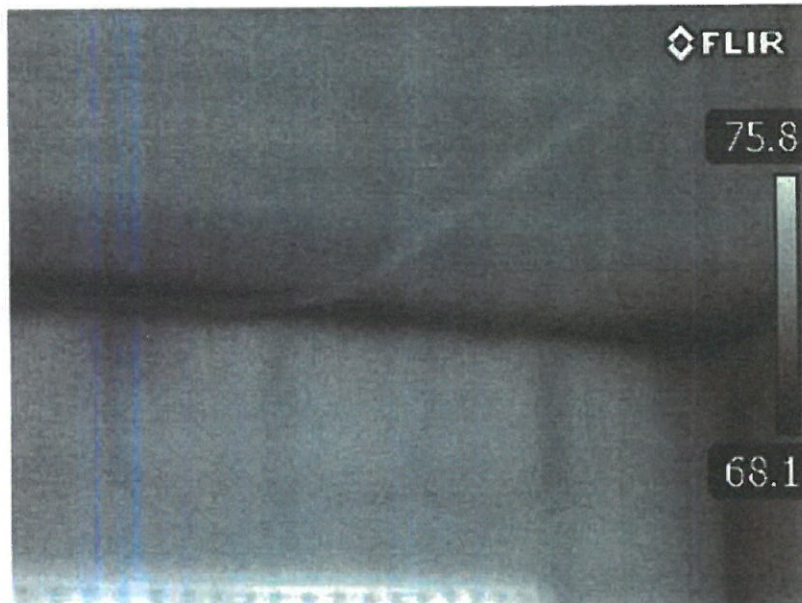
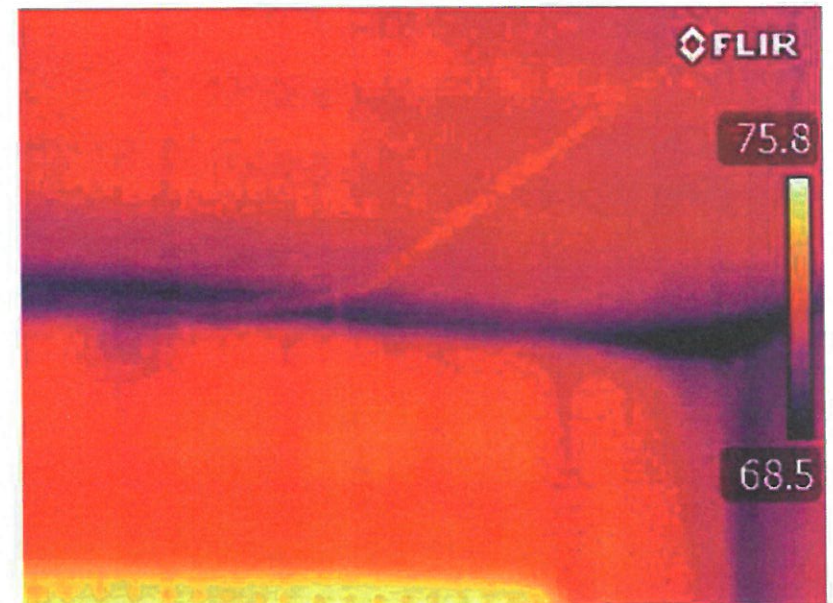
Area/Picture No. 201 Job No. 15-3129.1 Date 9/24/15

Location Room 202

Equipment Exterior Wall, Right of Window to Ceiling

Comments Thermograms show cold thermal patterns typical of latent moisture.

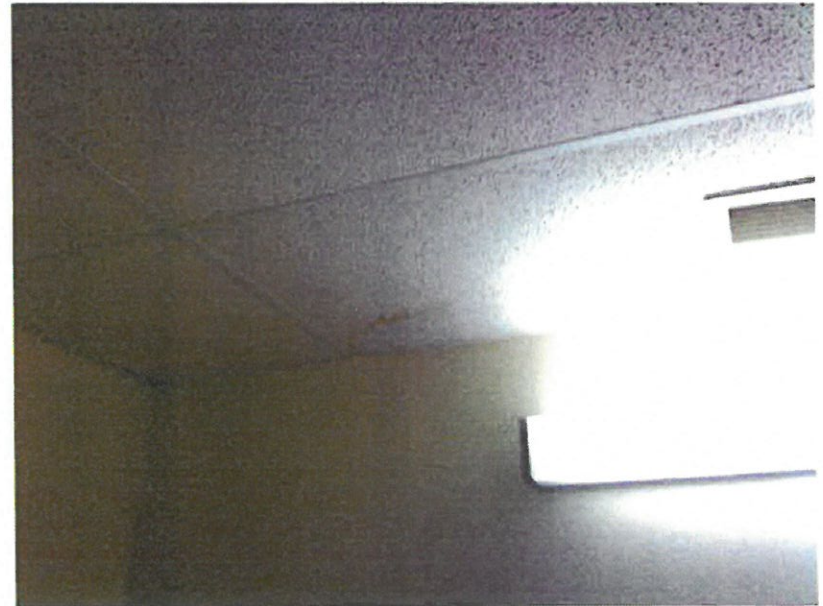
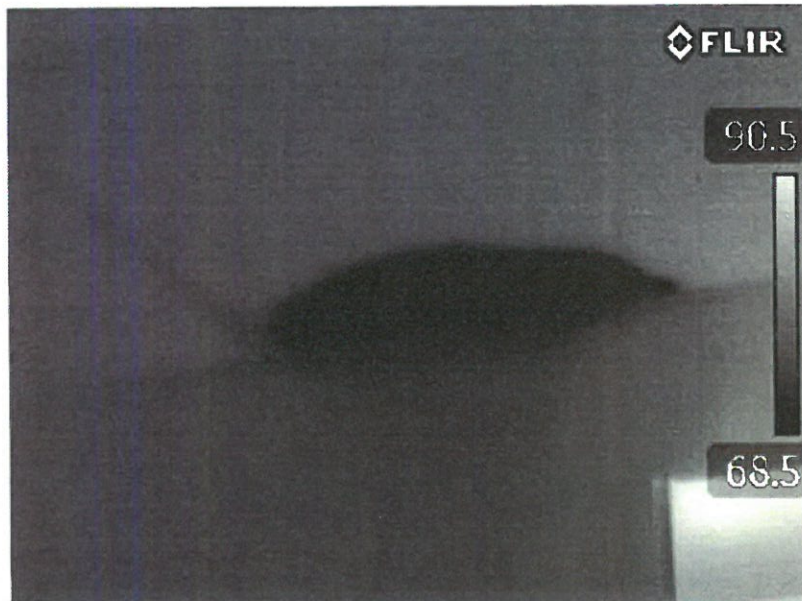
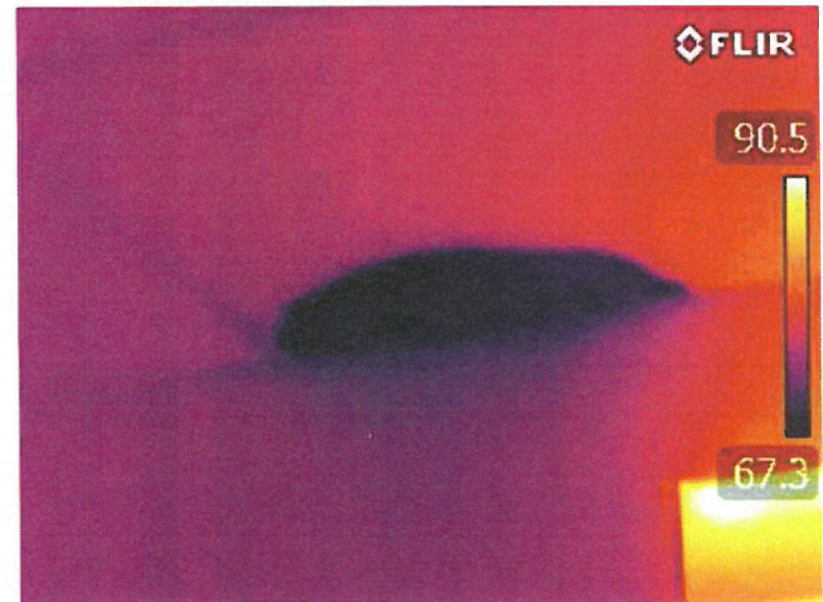
Area/Picture No. 241 Job No. 15-3129.1 Date 9/24/15

Location Room 112

Equipment Bathroom Ceiling Above Light

Comments Thermograms show cold thermal patterns typical of latent moisture.

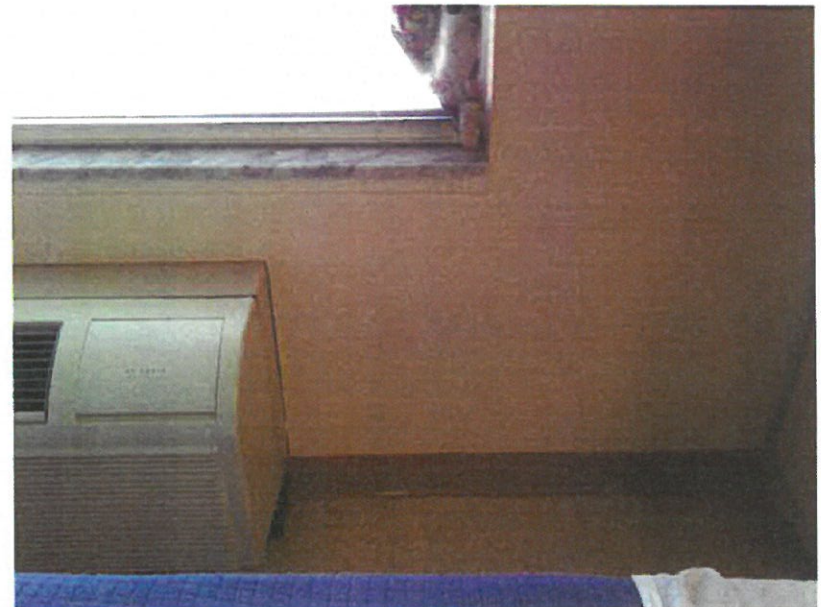
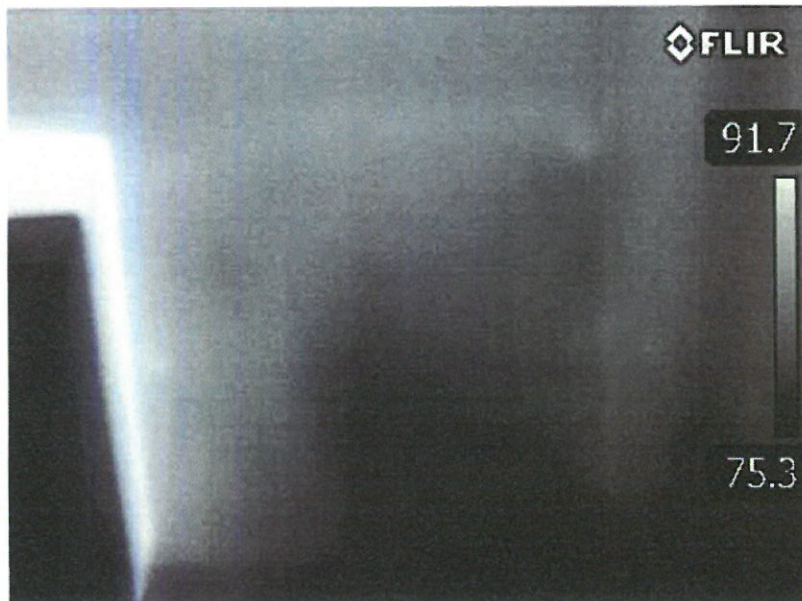
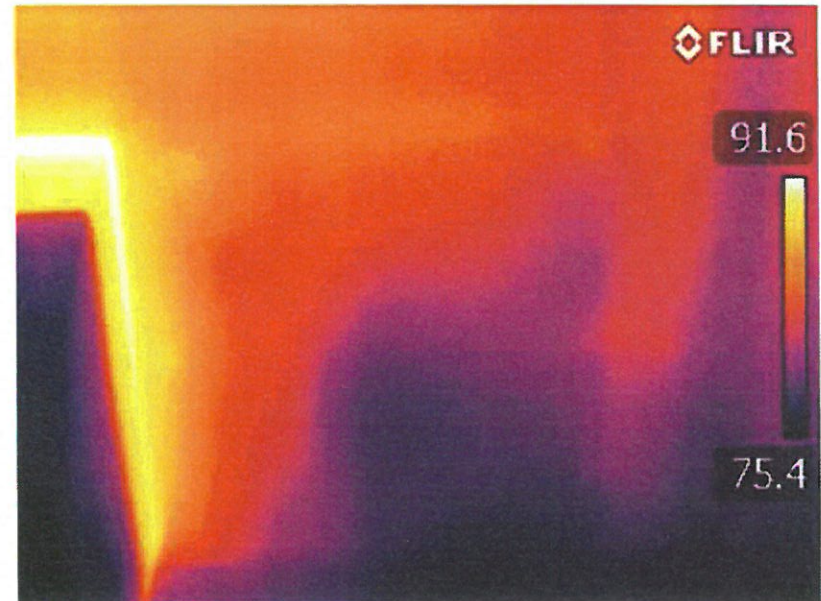
Area/Picture No. 282 Job No. 15-3129.1 Date 9/24/15

Location Room 102

Equipment Exterior Wall, Right of Unit

Comments Thermograms show cold thermal patterns typical of latent moisture.

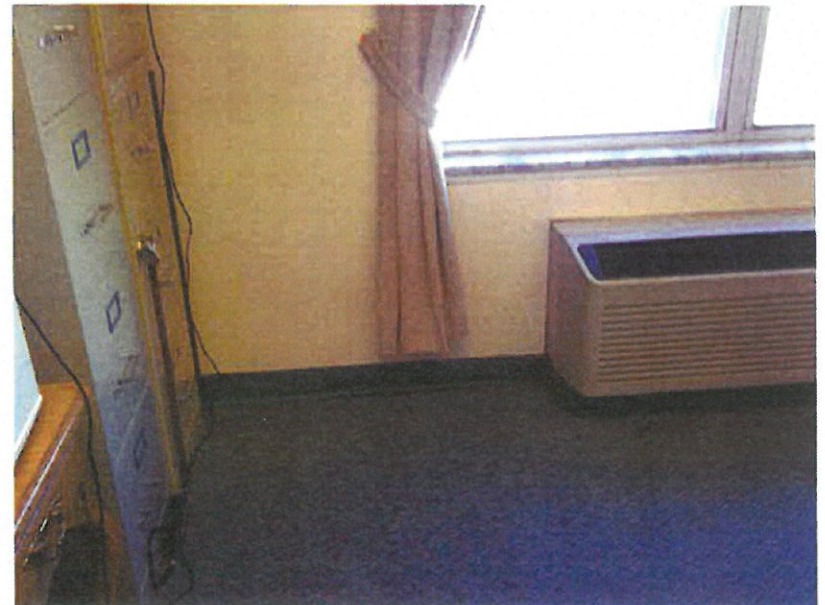
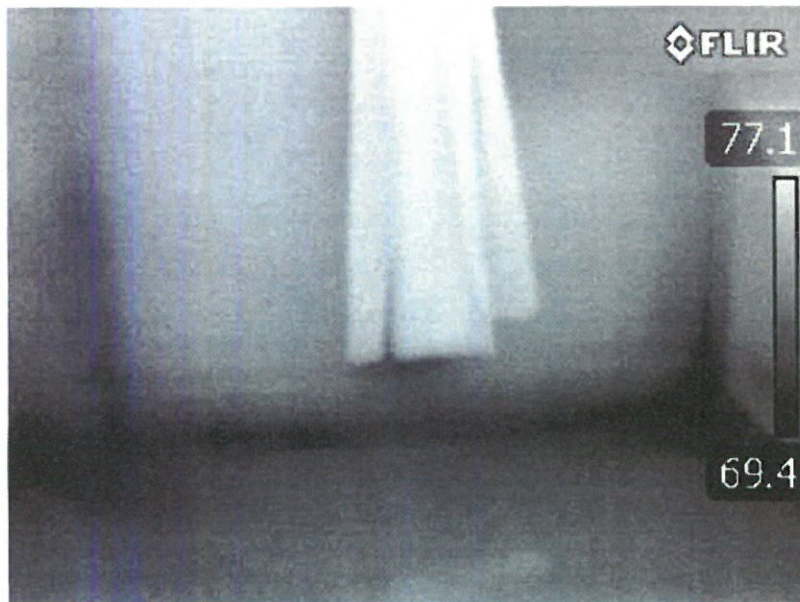
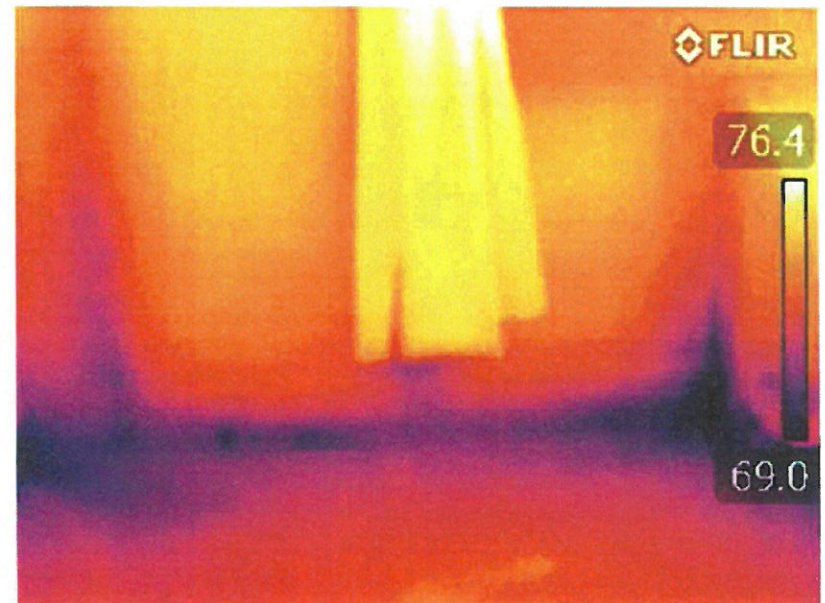
Area/Picture No. 307 **Job No.** 15-3129.1 **Date** 9/24/15

Location Nurse Admin. Training Office

Equipment Exterior Wall, Left of Unit

Comments Thermograms show cold thermal patterns typical of latent moisture.

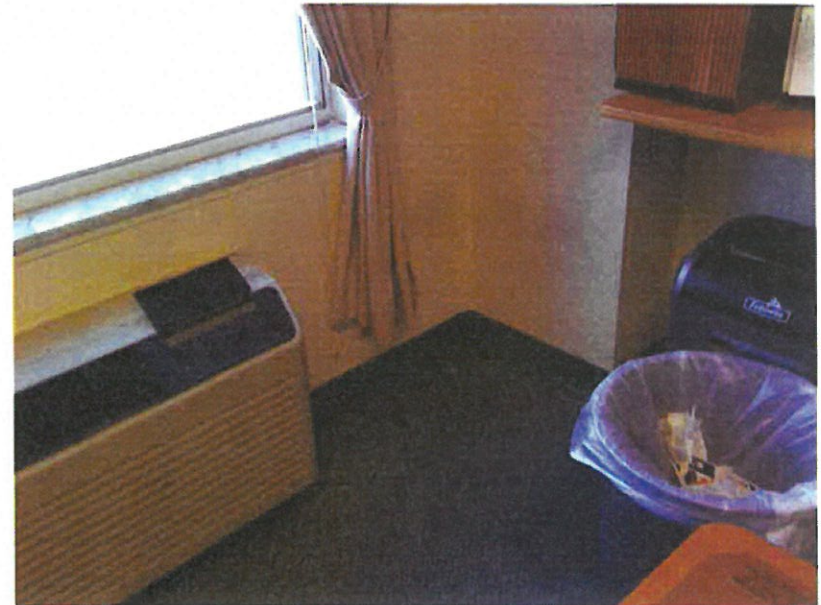
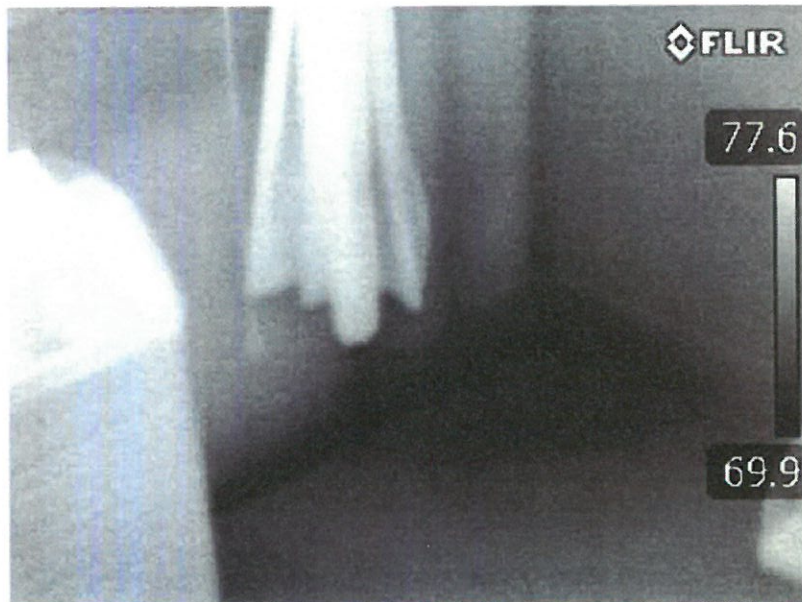
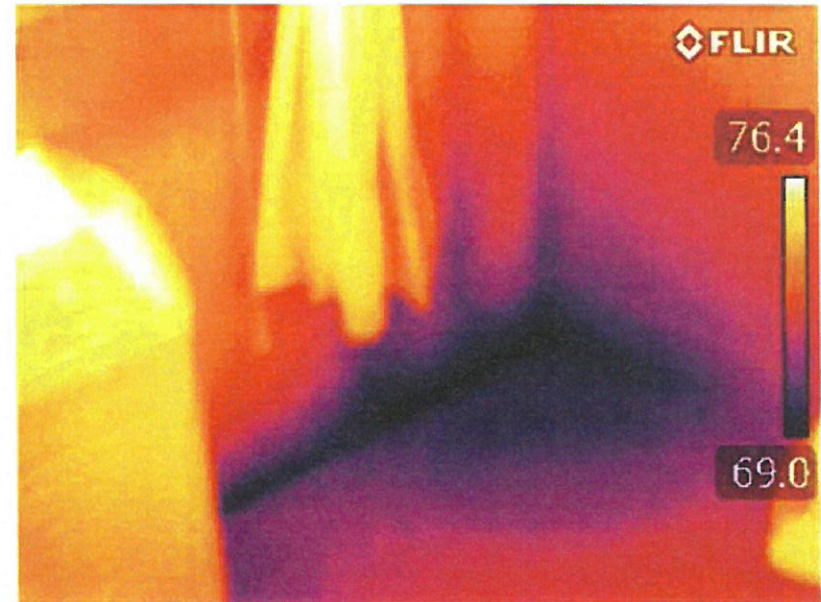
Area/Picture No. 308 Job No. 15-3129.1 Date 9/24/15

Location Nurse Admin. Training Office

Equipment Exterior Wall, Right of Unit

Comments Thermograms show cold thermal patterns typical of latent moisture.

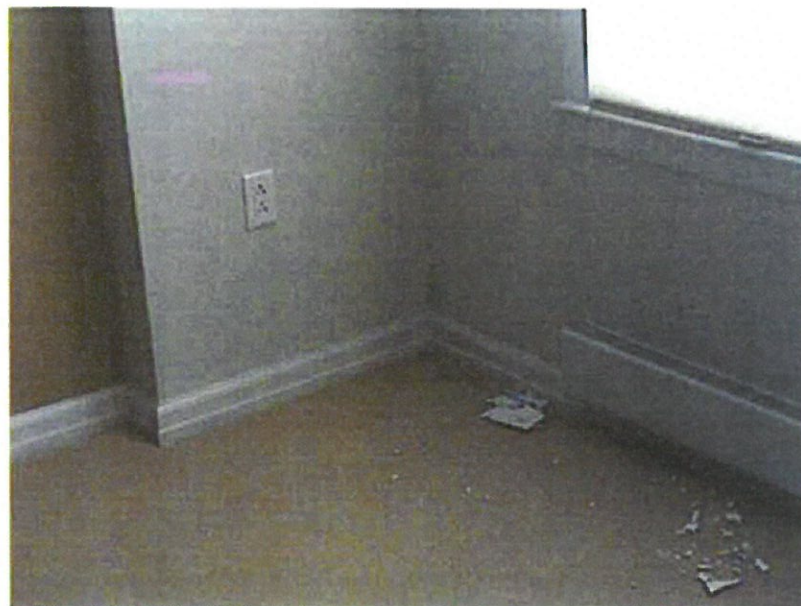
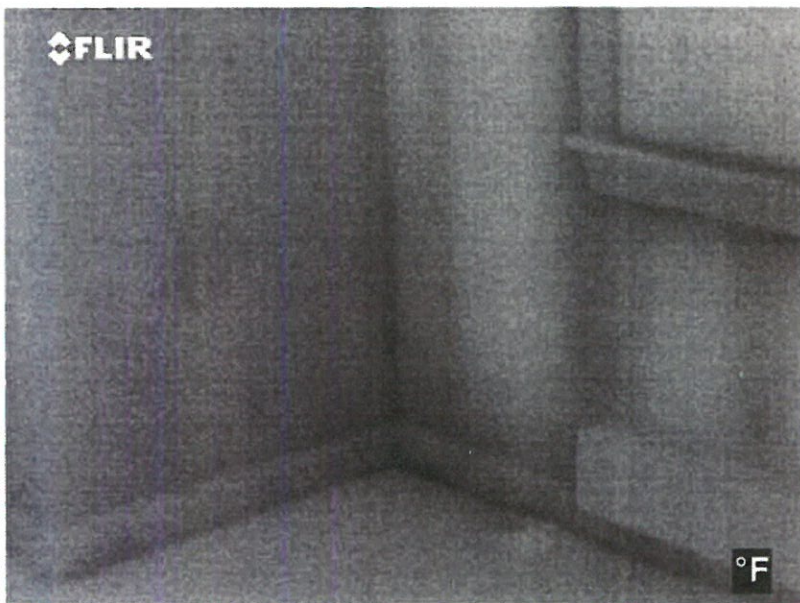
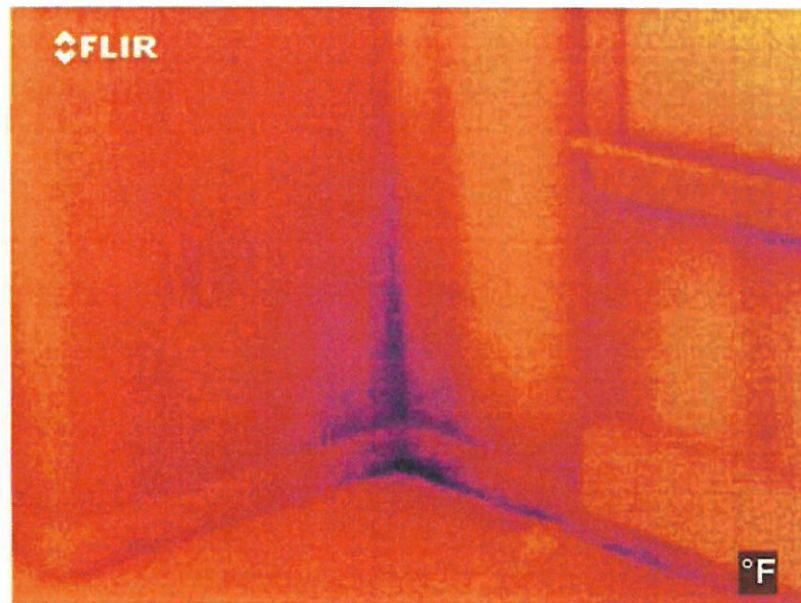
Area/Picture No. 11 Job No. 16-3149.1 Date 1/29/16

Location 3rd Floor, Unit 302

Equipment 2nd Bedroom, Bottom NW Corner, Left Side

Comments Thermogram shows pattern typical of moisture infiltration.

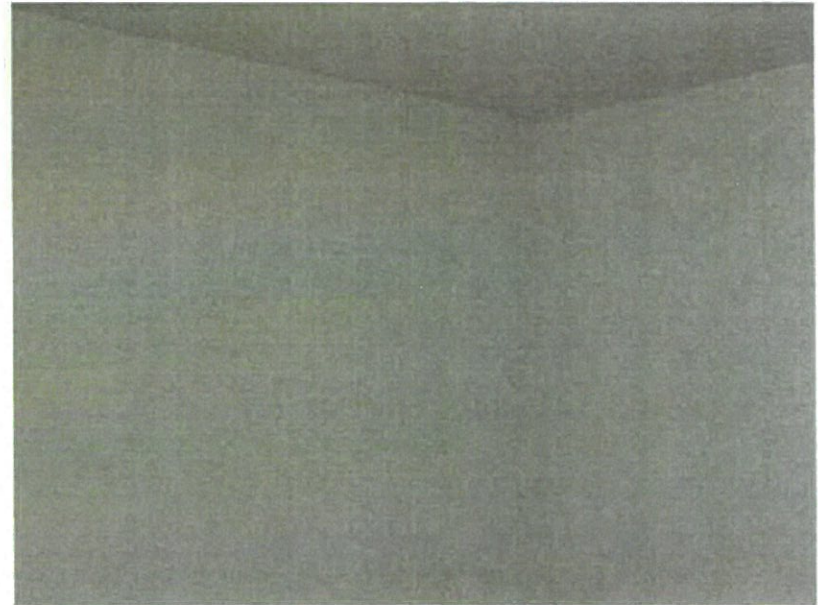
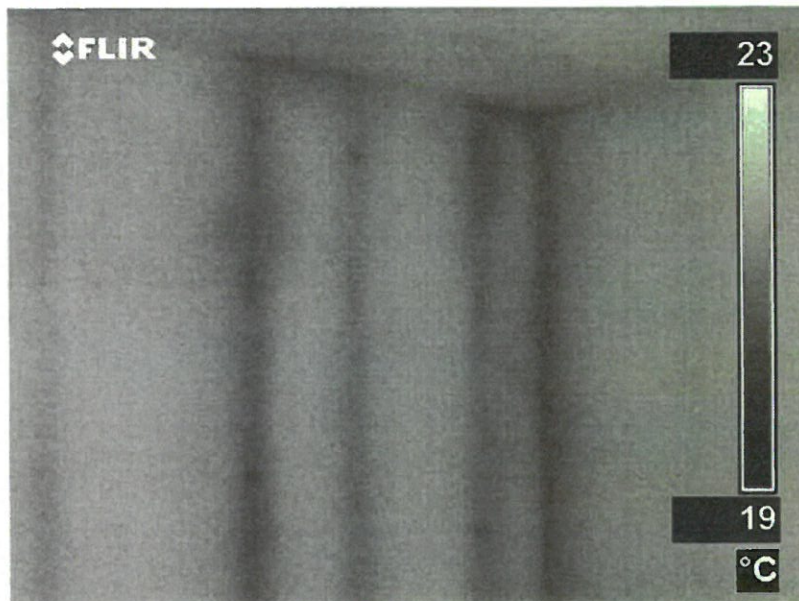
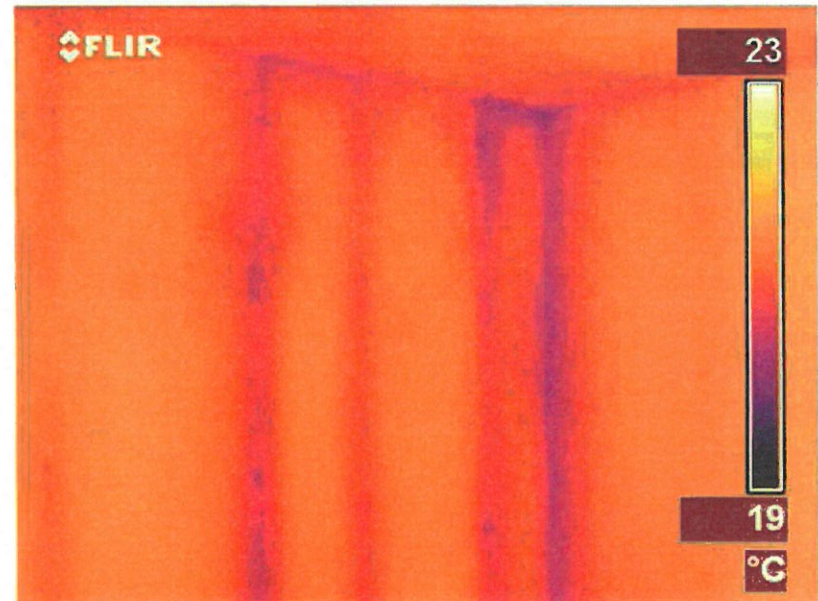
Area/Picture No. 5 Job No. 12-2825.3 Date 9/19/12

Location 4th Floor, Unit 405

Equipment Master Bedroom, Right Corner, Top

Comments Thermogram shows thermal pattern typical of moisture infiltration.

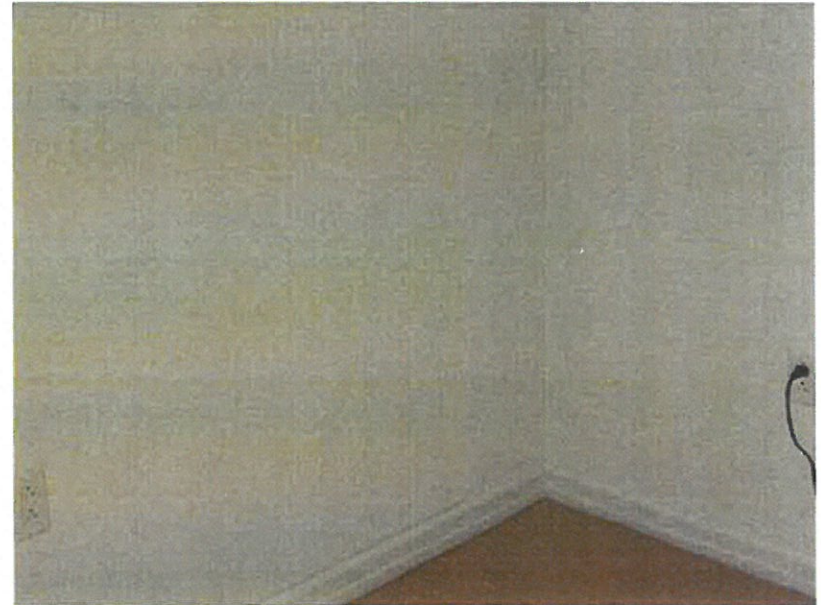
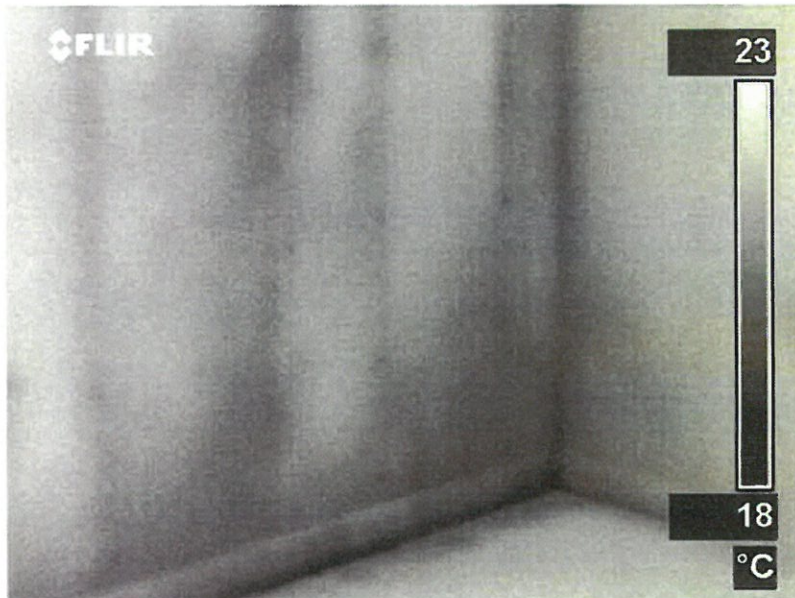
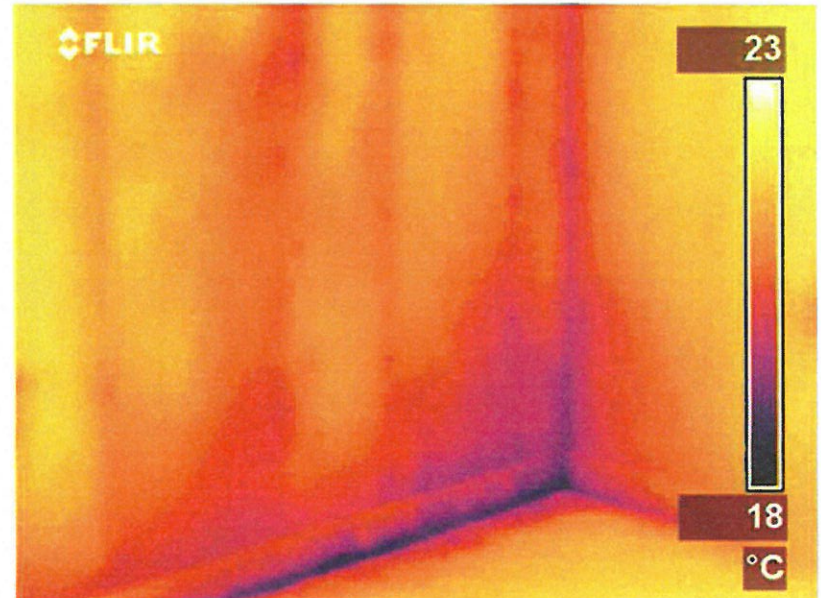
Area/Picture No. 6 Job No. 12-2825.3 Date 9/19/12

Location 4th Floor, Unit 405

Equipment Master Bedroom, Right Corner, Bottom

Comments Thermogram shows thermal pattern typical of moisture infiltration.

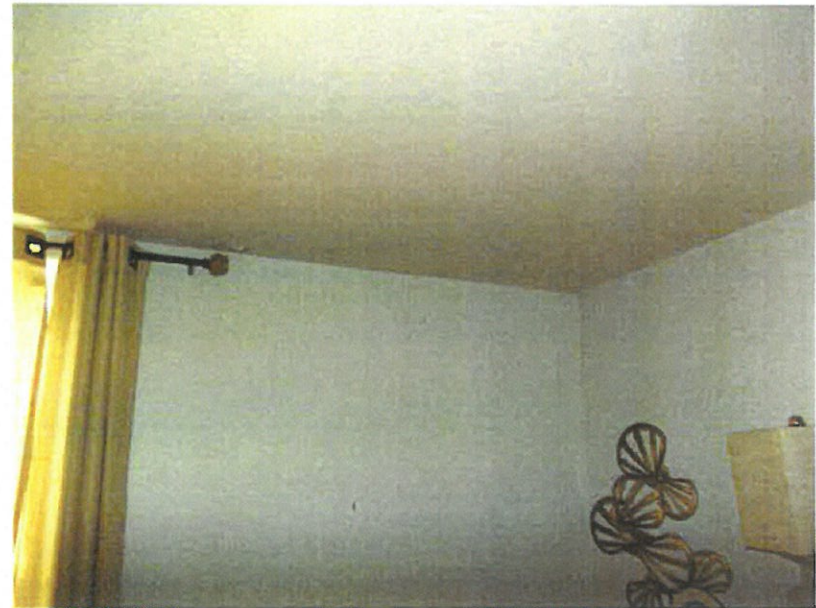
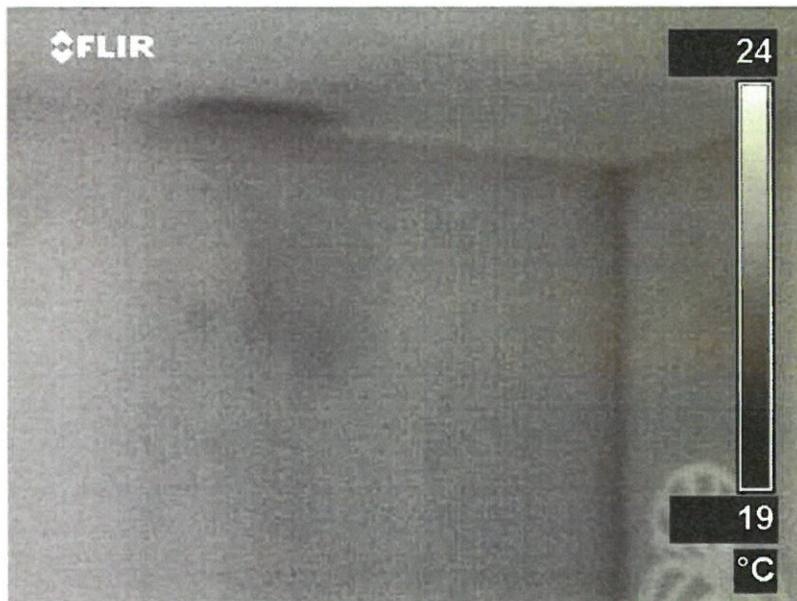
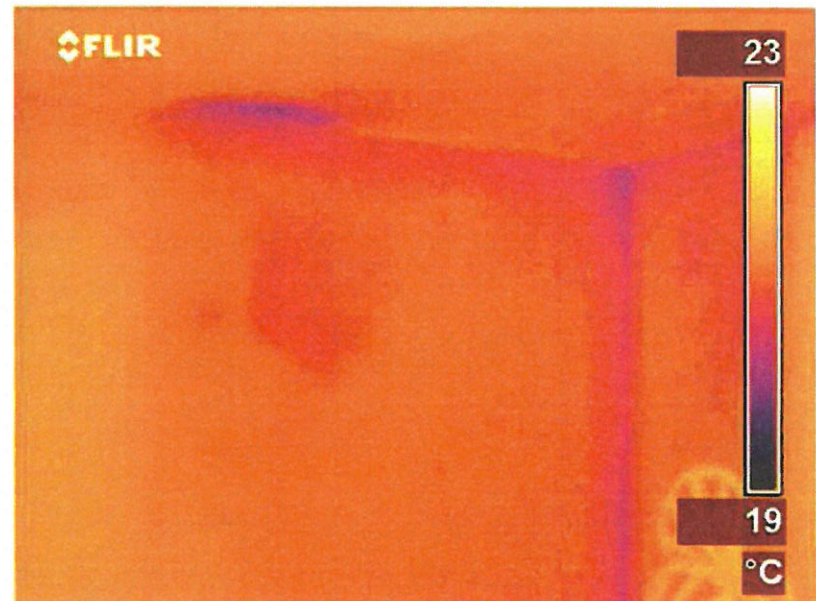
Area/Picture No. 3 **Job No.** 12-2825.3 **Date** 9/19/12

Location 3rd Floor, Unit 306

Equipment Guest Bedroom, Right of Window

Comments Thermogram shows thermal pattern typical of moisture infiltration.
