**ELECTRIC FIELD VECTOR MAPPING
EFVM[®] TEST REPORT**

**ABC Company
123 Main Street
Anytown, USA**

**Electric Field Vector Mapping
EFVM® Test Report
Our Report Number: 00-0000.0**

International Leak Detection performed the EFVM[®] test of the waterproofing membrane installed at the ABC Company facility located at 123 Main Street in Anytown, NY. The EFVM[®] test was requested to confirm the integrity of the waterproofing membrane prior to the installation of the overburden.

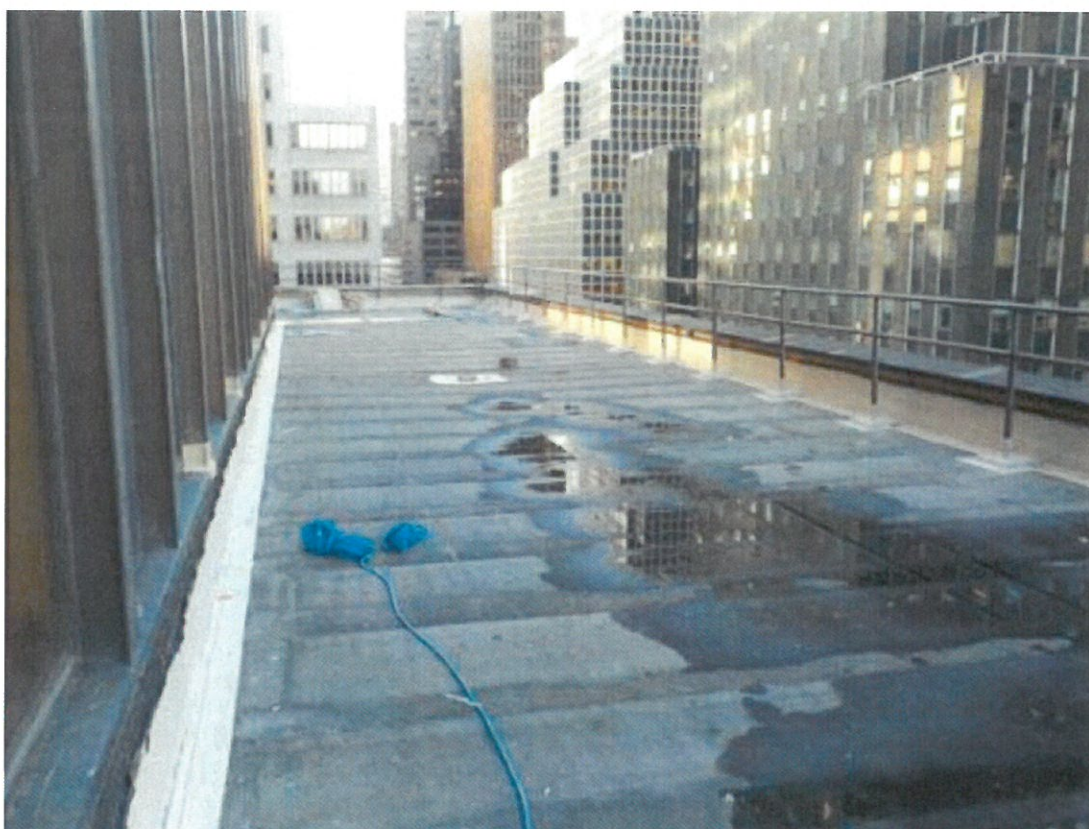
Building Overview

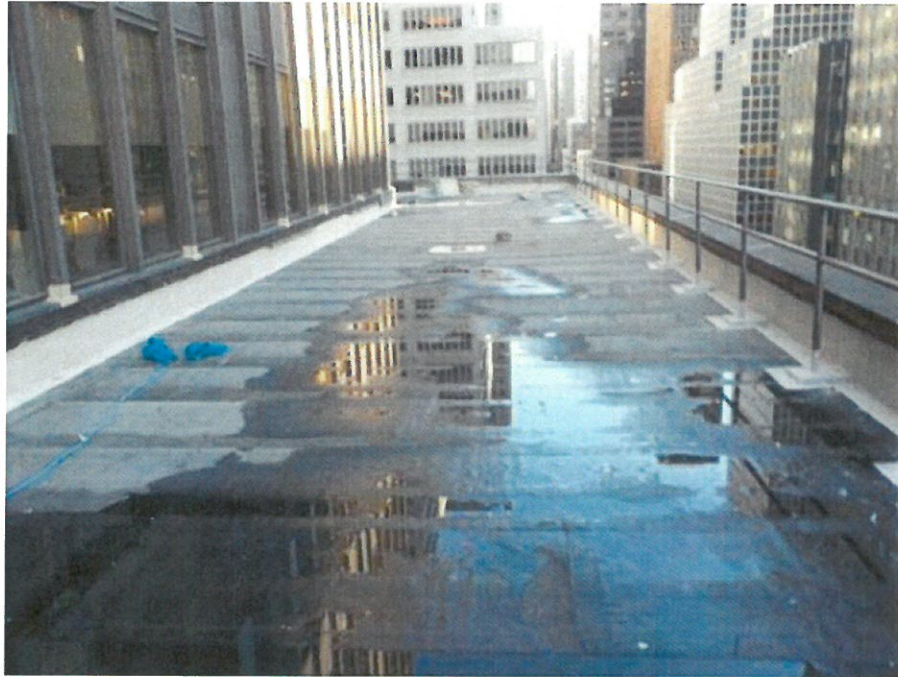
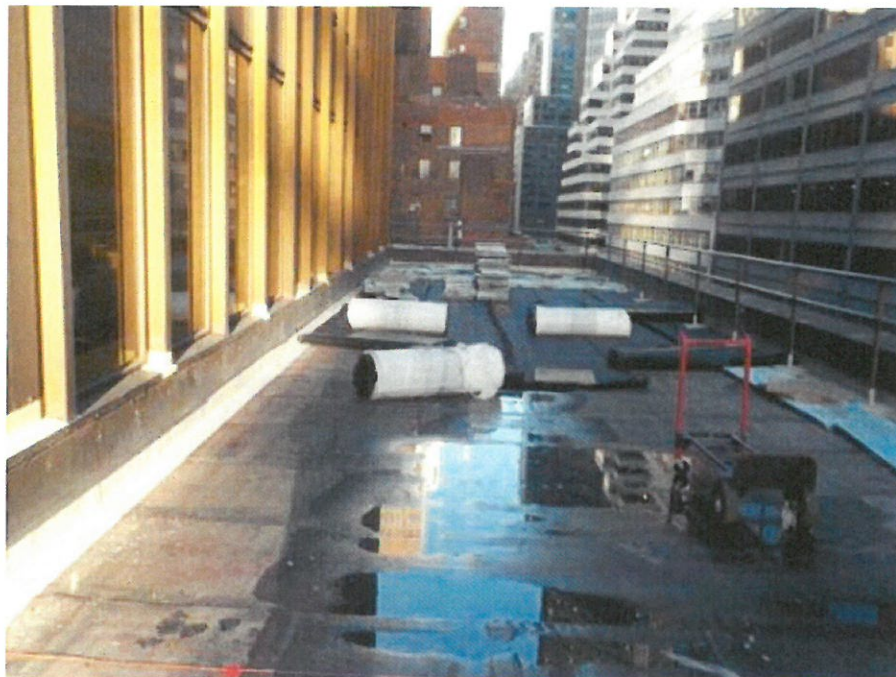
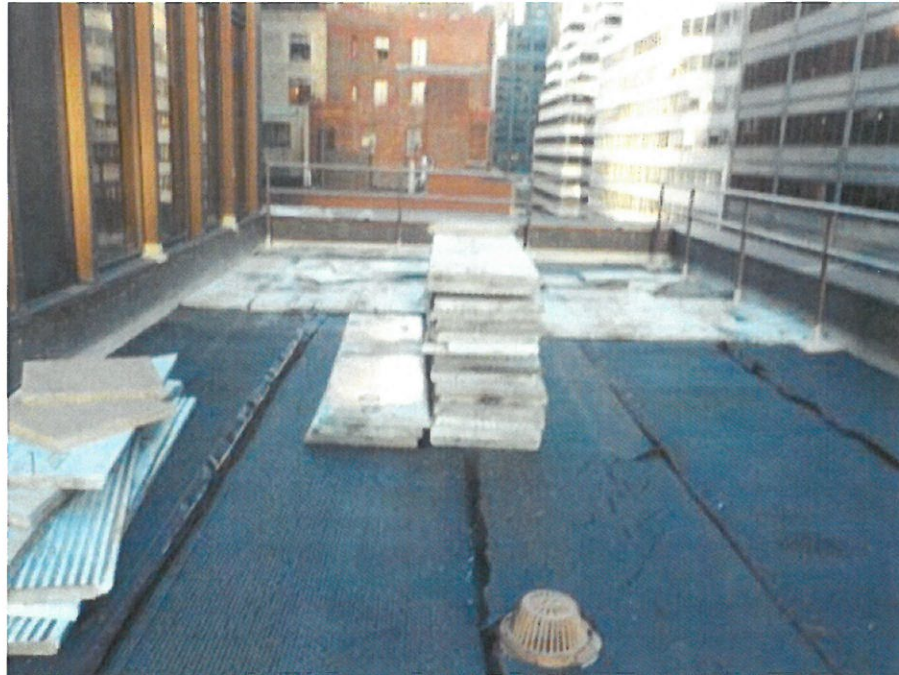
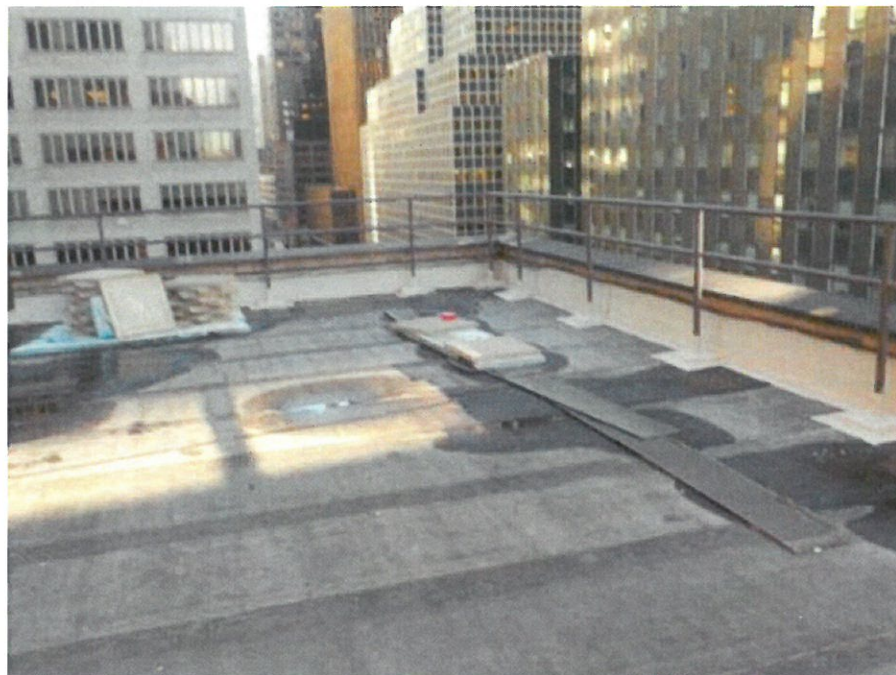
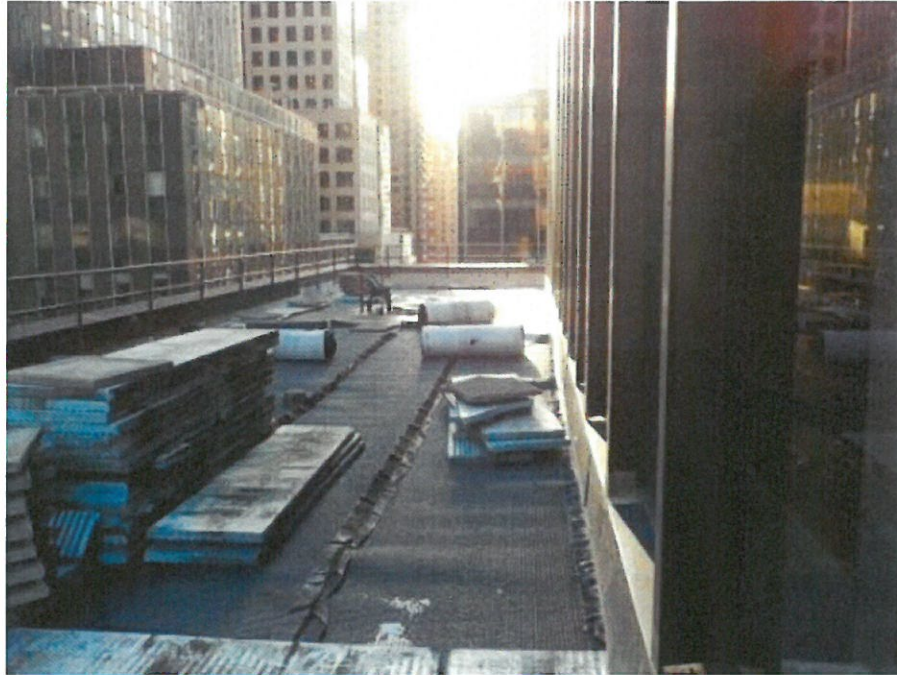
The EFVM[®] potentiometer did not detect a current flow that would indicate a possible membrane breach.

The EFVM[®] test confirmed that the membrane was isolating the potential difference. Therefore, the membrane was deemed watertight at the conclusion of the EFVM[®] test.

**Overview of
Area 107.0**
