INFRASONIC™ STEAM SURVEY

ABC Company 123 Main Street Anytown, USA

> RE: INFRASONIC™ STEAM SYSTEM SURVEY REPORT OUR JOB NUMBER: 13-1479.37

THERMOGRAPHER'S COMMENTS OUR JOB NUMBER: 13-1479.37

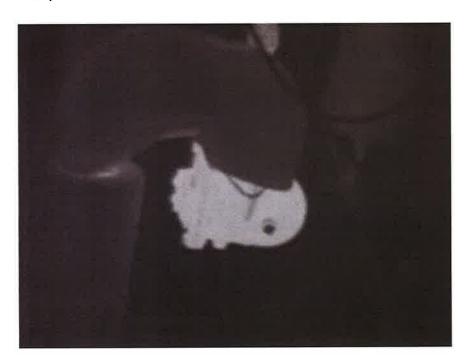
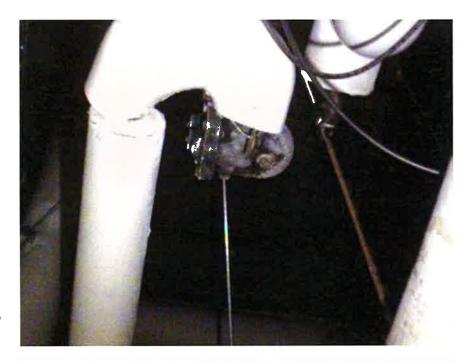
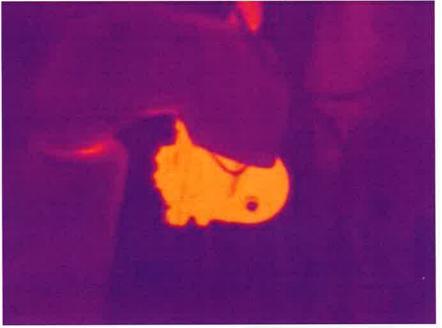
Area/Picture No. 1 **Job No.** 13-1479.37 **Date** 2/19/13

Equipment Steam Trap #14

Comments Trap Temperatures:

Inlet Outlet 216°F 216°F

Note: Ultrasonic unit detected steam passing.

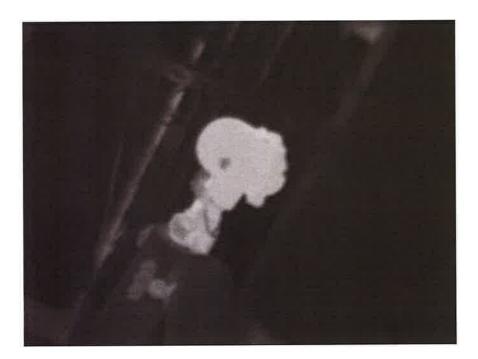
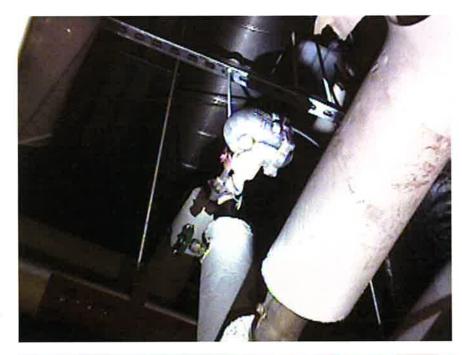
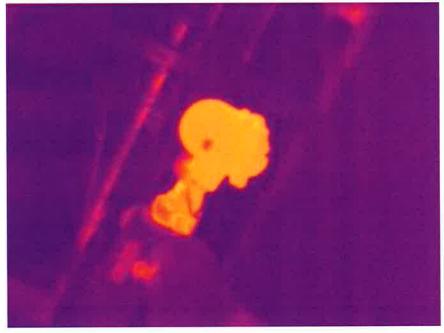
Area/Picture No. 2 Job No. 13-1479.37 Date 2/19/13

Equipment Steam Trap #21

Comments Trap Temperatures:

Inlet Outlet 216°F 212°F

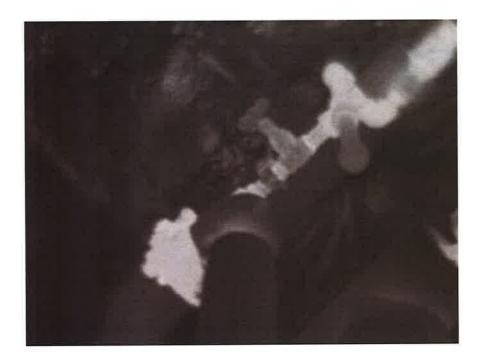
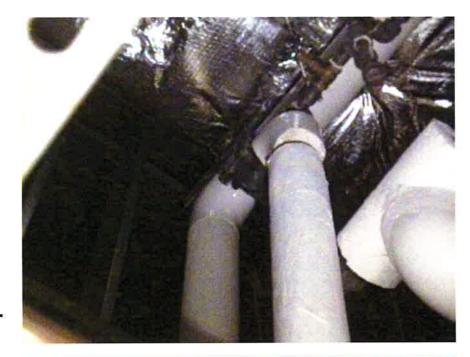
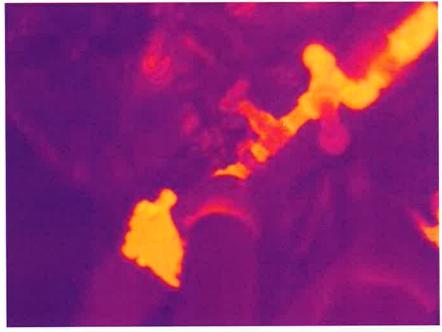
Area/Picture No. 3 Job No. 13-1479.37 Date 2/19/13

Equipment Steam Trap #26

Comments Trap Temperatures:

Inlet Outlet 221°F 214°F

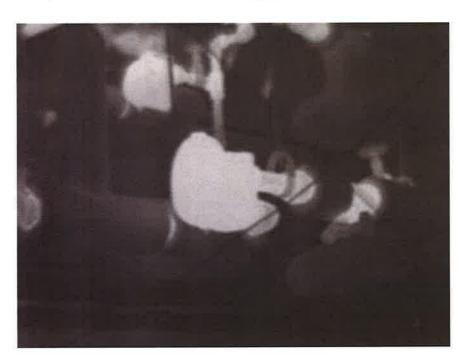
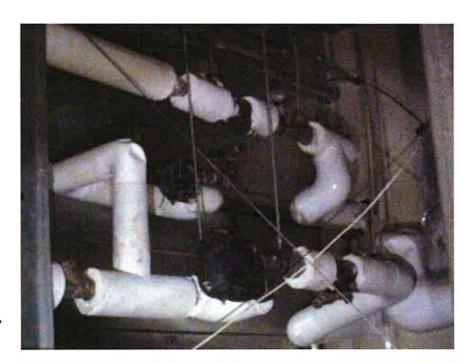
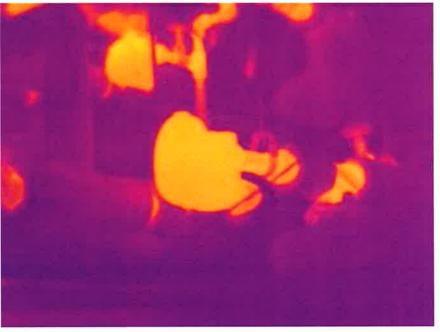
Area/Picture No. 4 Job No. 13-1479.37 Date 2/19/13

Equipment Steam Trap 3"

Comments Trap Temperatures:

Inlet Outlet 218°F 218°F

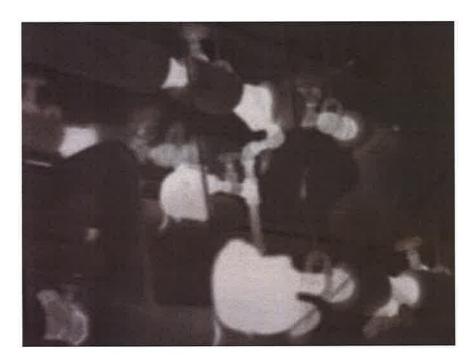
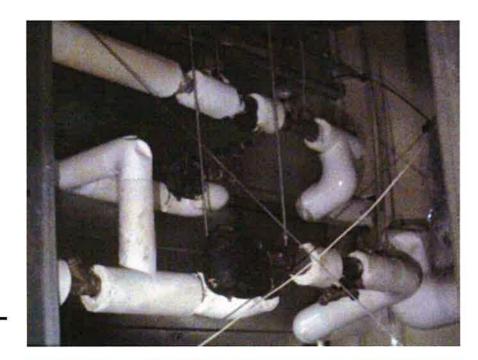
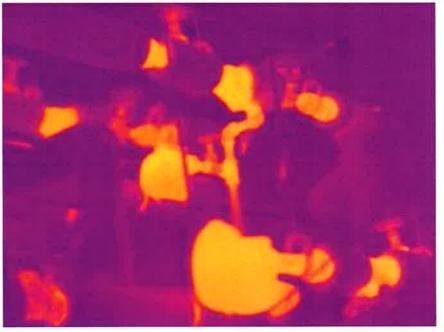
Area/Picture No. 5 **Job No.** 13-1479.37 **Date** 2/19/13

Equipment Steam Trap 3/4"

Comments Trap Temperatures:

Inlet Outlet 218°F 211°F

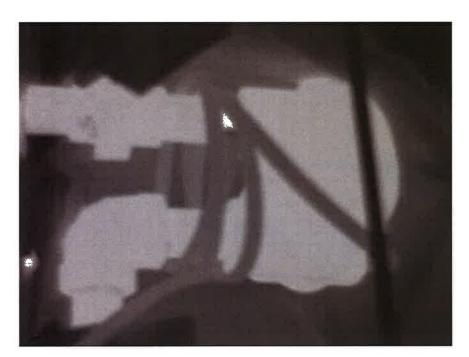
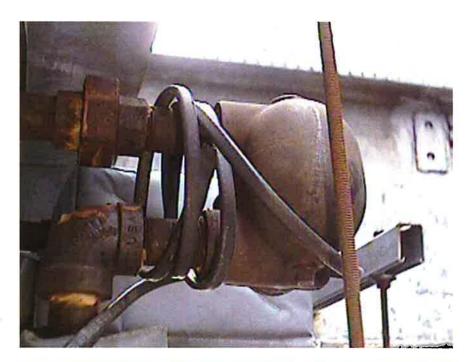
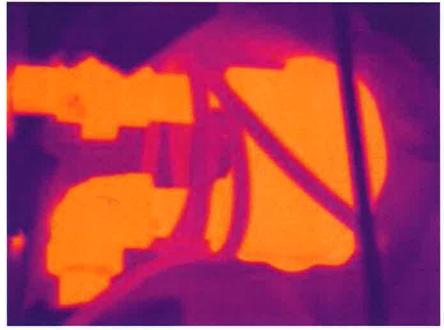
Area/Picture No. 6 **Job No.** 13-1479.37 **Date** 2/19/13

Equipment Steam Trap #144

Comments Trap Temperatures:

Inlet Outlet 214°F 212°F
