INFRARED ELECTRICAL SYSTEM SURVEY

*ABC Company
123 Main Street
Anytown, USA*

*#1 Elementary School
#2 Elementary School
#3 Elementary School
#4 Elementary School
Middle School
Anytown, US*

RE: INFRARED ELECTRICAL SYSTEM SURVEY REPORT
OUR JOB NUMBER: 13-0000.00

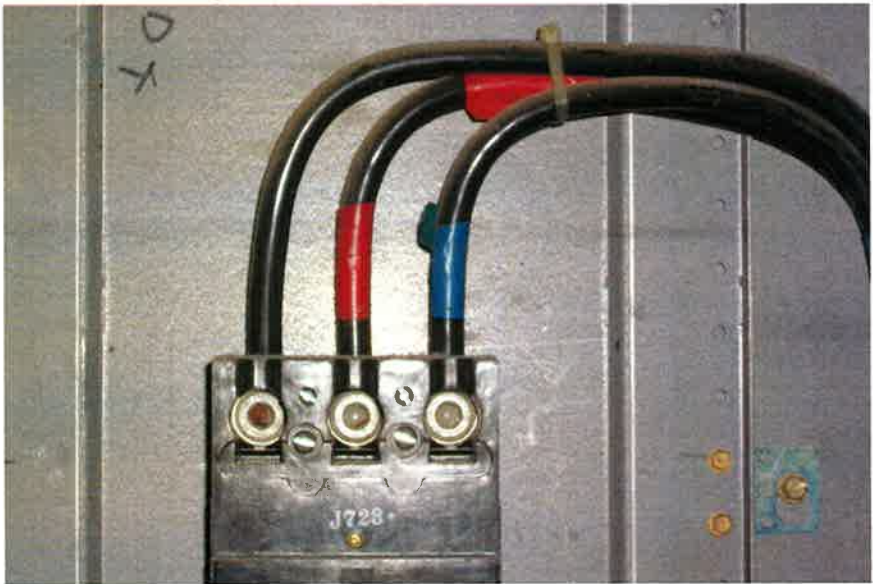
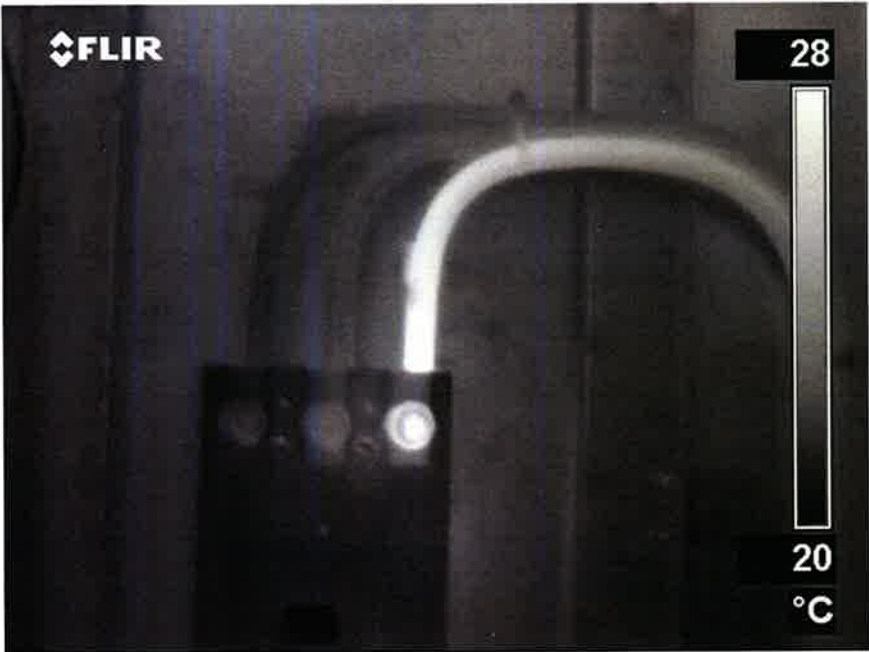
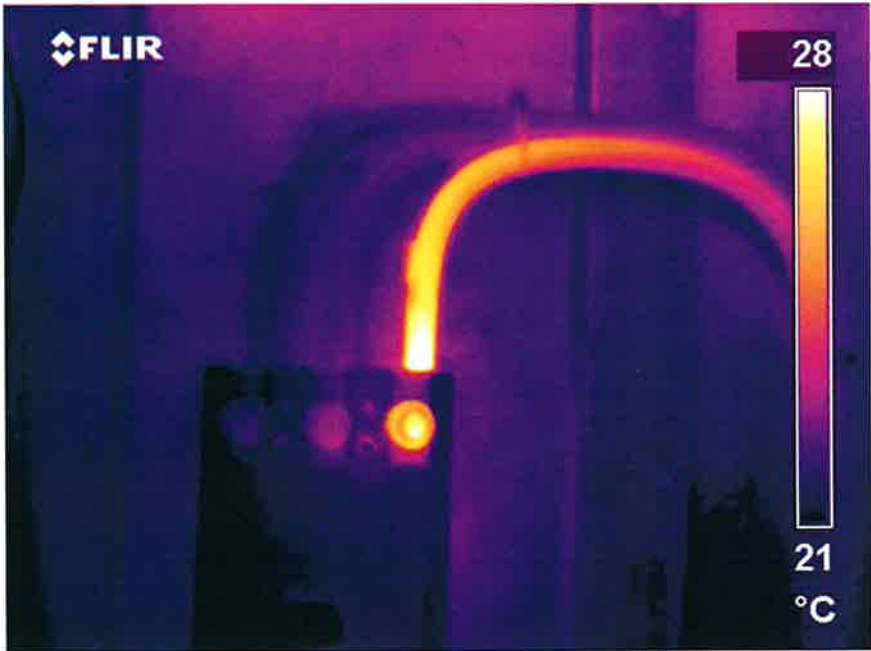
Area/Picture No. 1 Job No. 13-0000.00 Date 1/3/13
Location #1 Elementary School, Boiler Room
Equipment Power Panel, BA, Main Circuit Breaker
Wind Speed N/A Wind From N/A Sky Indoor
Emiss. 1.00 B/G N/A° Distance 5' Lens 1x
Rated Load 175 Amps Measured Load 18 Amps % Load 10.29
Ambient Temp 20°C 7 ° Rise Over Left Connection
Comments Conductor Connection Temperatures:

Left	Middle	Right
	22°C	23°C	29°C
Amps	18	---	16

Priority 2
Repair Check Date ° Rise Over
Notes

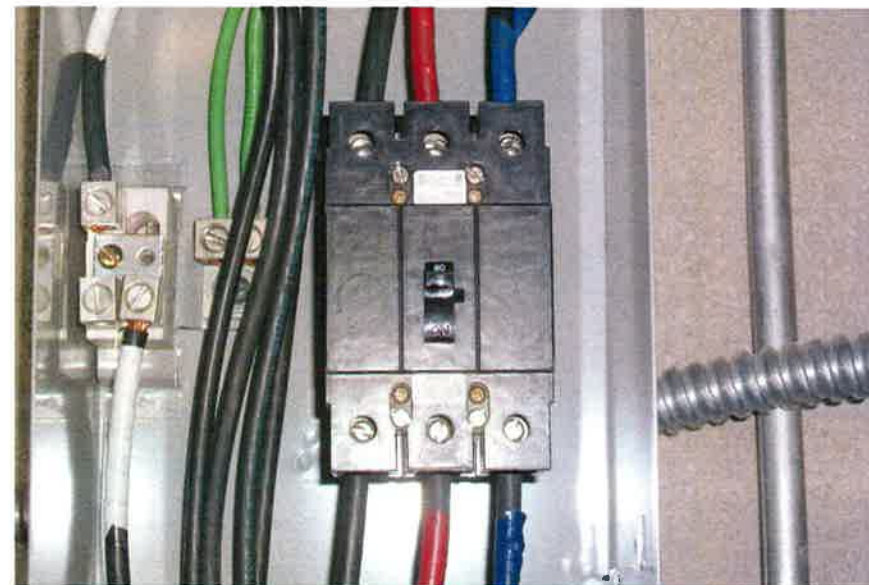
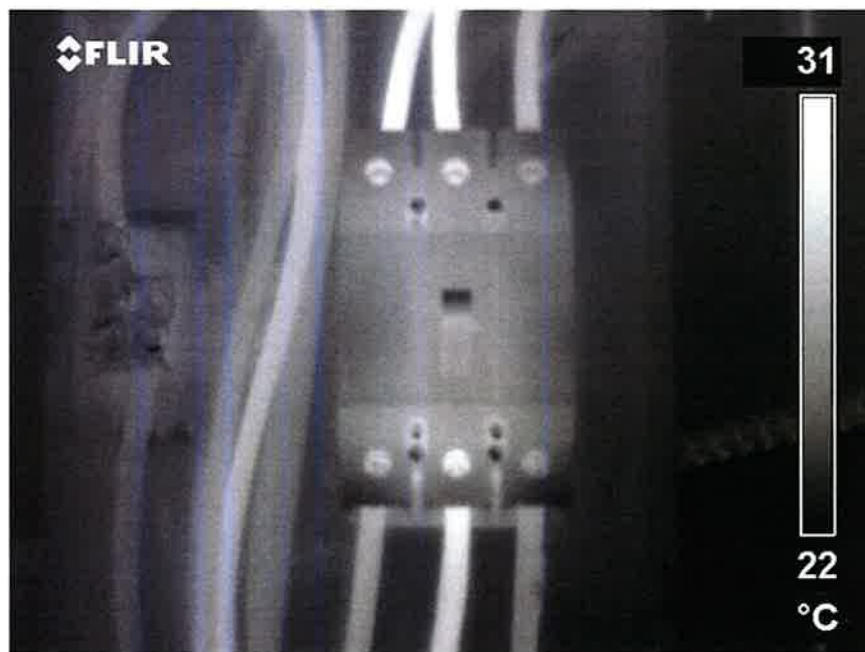
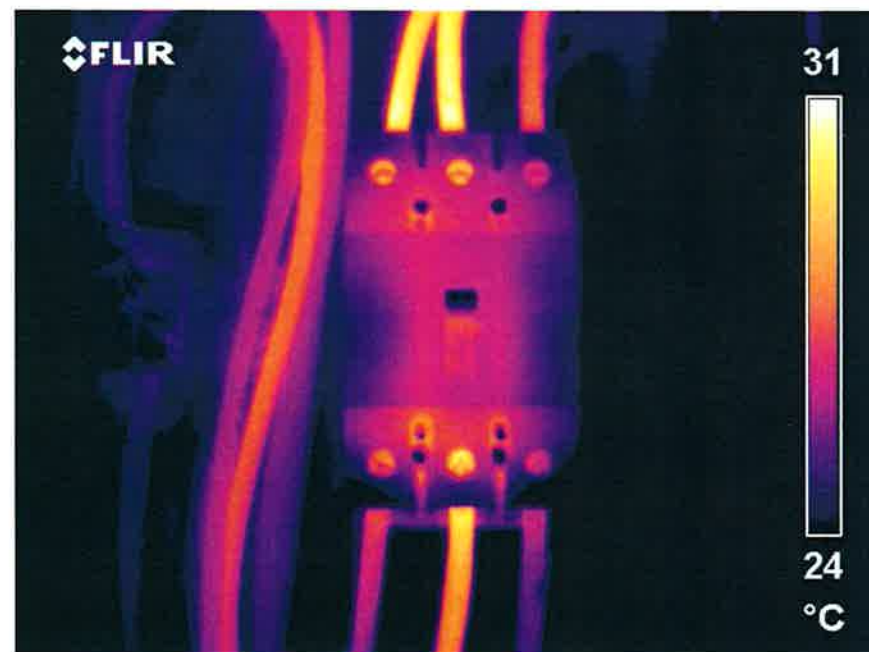
Area/Picture No. 2 Job No. 13-0000.00 Date 1/3/13
Location #1 Elementary School, Boiler Room
Equipment Circuit Breaker, Disconnect for AP-1 Panel
Wind Speed N/A Wind From N/A Sky Indoor
Emiss. 1.00 B/G N/A° Distance 5' Lens 1x
Rated Load 80 Amps Measured Load 33 Amps % Load 41.25
Ambient Temp 20°C 4 ° Rise Over Upper Right Connection

Comments Conductor Connection Temperatures:

Left	Middle	Right
Upper	31°C	31°C	27°C
Lower	27°C	30°C	27°C
Amps	18	33	18.6

Priority 2

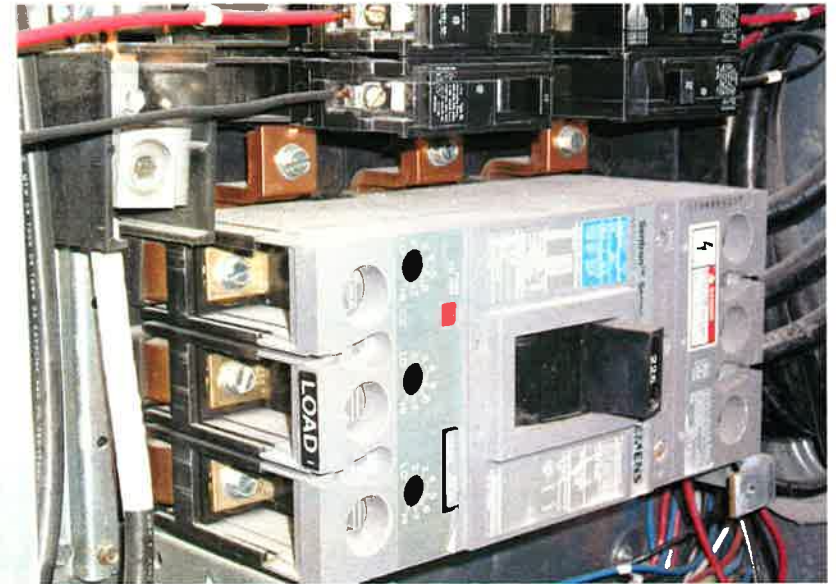
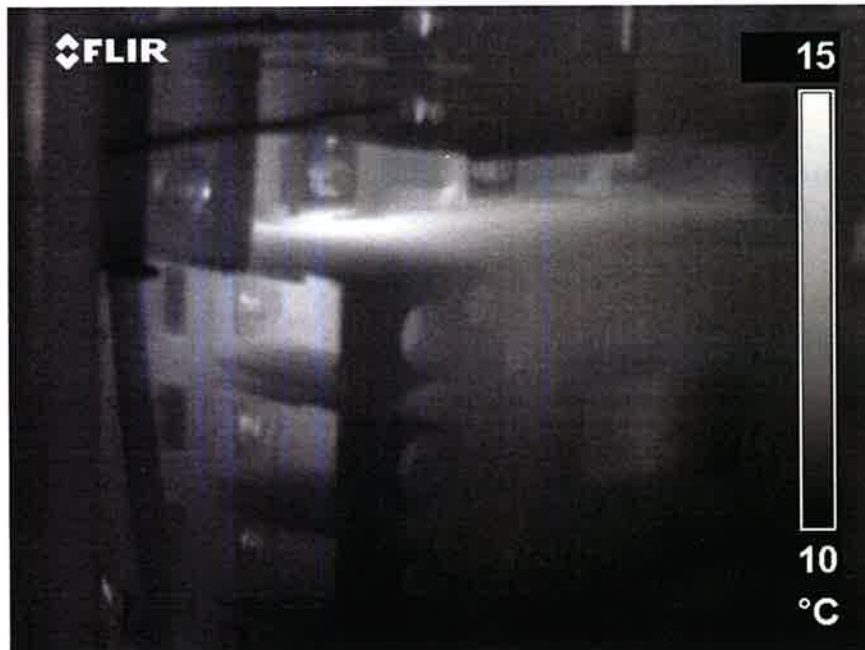
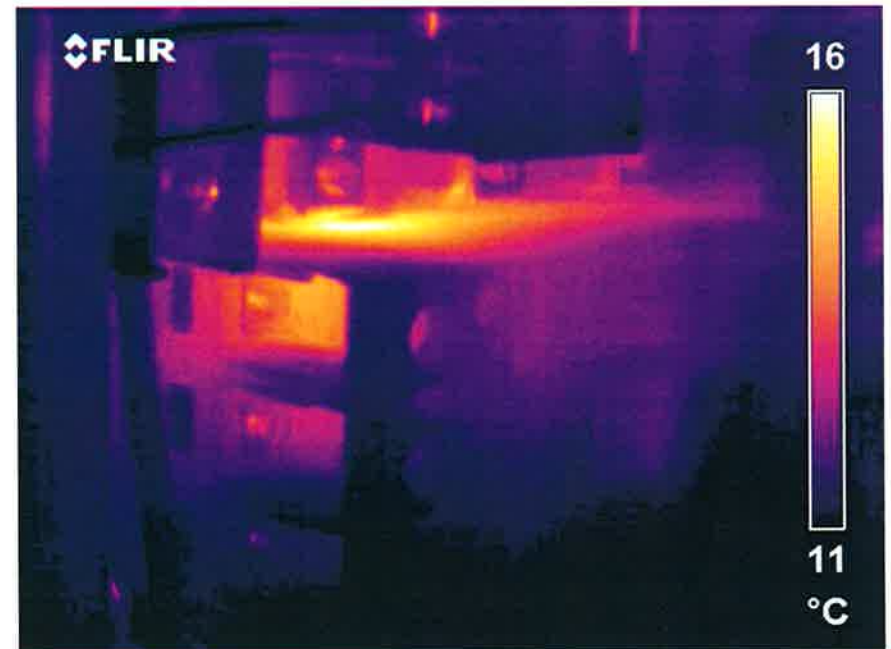
Area/Picture No. 3 Job No. 13-0000.00 Date 1/3/13

Ambient Temp 17°C 3 ° Rise Over Right Connection

Comments Bus Connection Temperatures:

Left	Middle	Right
15°C	13°C	12°C

Priority 3

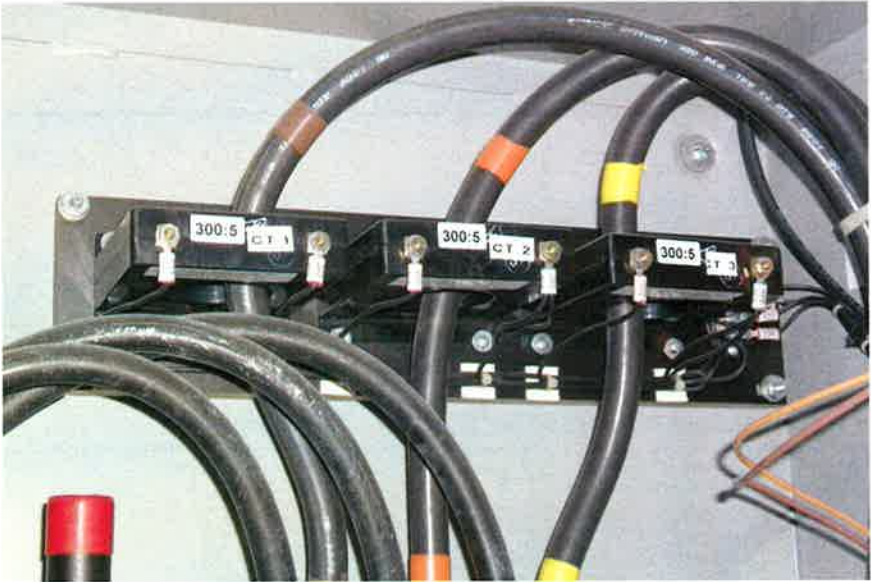
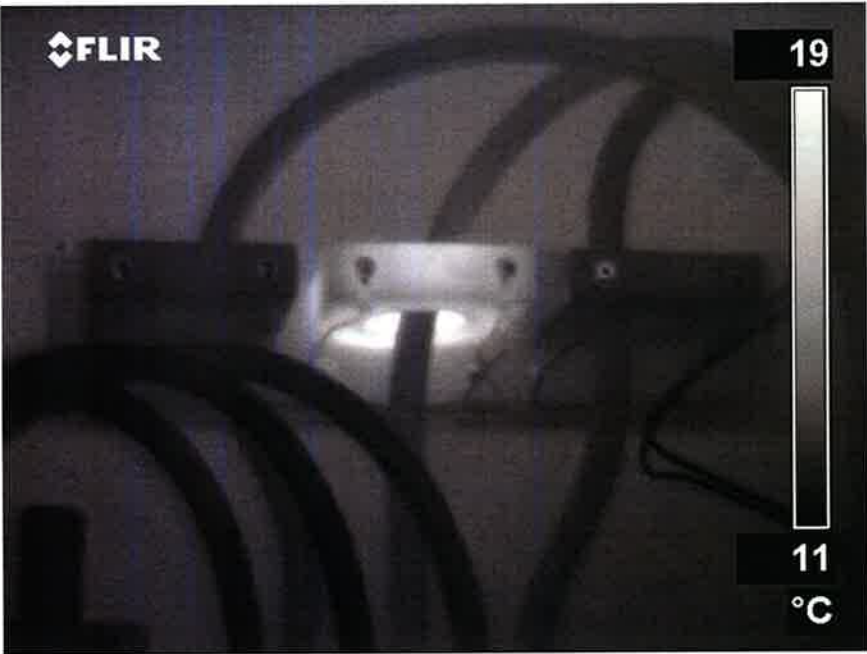
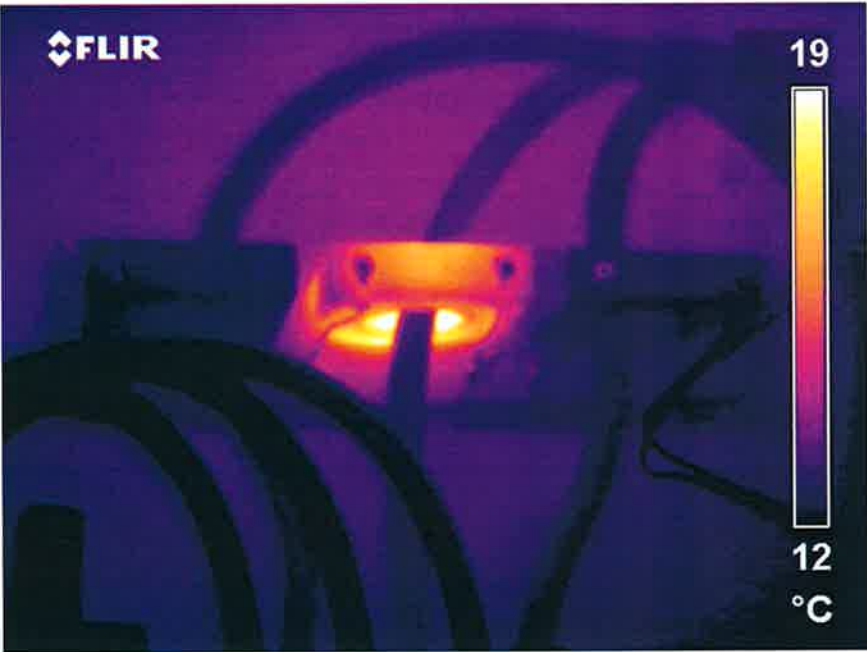
Area/Picture No. 4 Job No. 13-0000.00 Date 1/3/13
Location Middle School, Electrical Panel Room
Equipment ATS, ATS-2
Wind Speed N/A Wind From N/A Sky Indoor
Emiss. 1.00 B/G N/A° Distance 5' Lens 1x
Rated Load N/A Measured Load N/A % Load
Ambient Temp 17°C 8 ° Rise Over Left CT
Comments CT Temperatures:
 CT-1 CT-2 CT-3
 12°C 20°C 12°C

Priority 2
Repair Check Date ° Rise Over
Notes

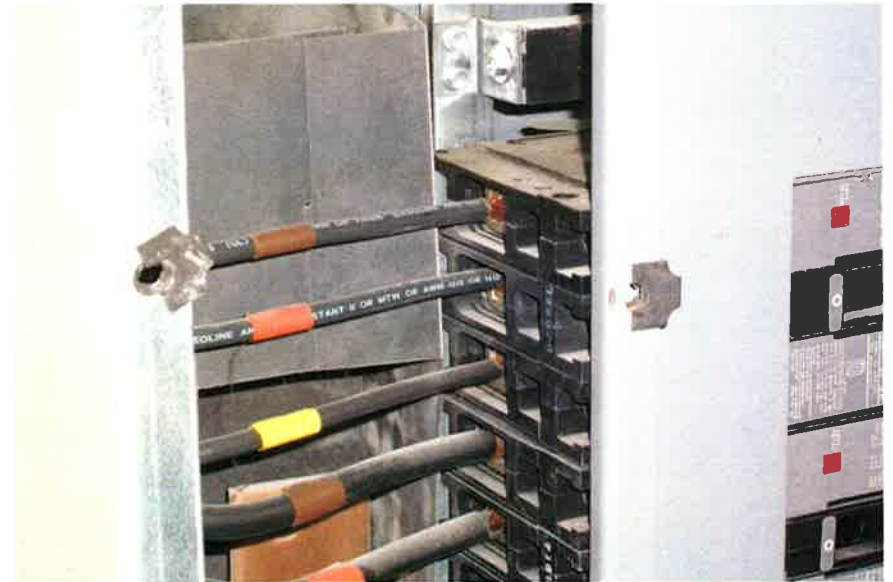
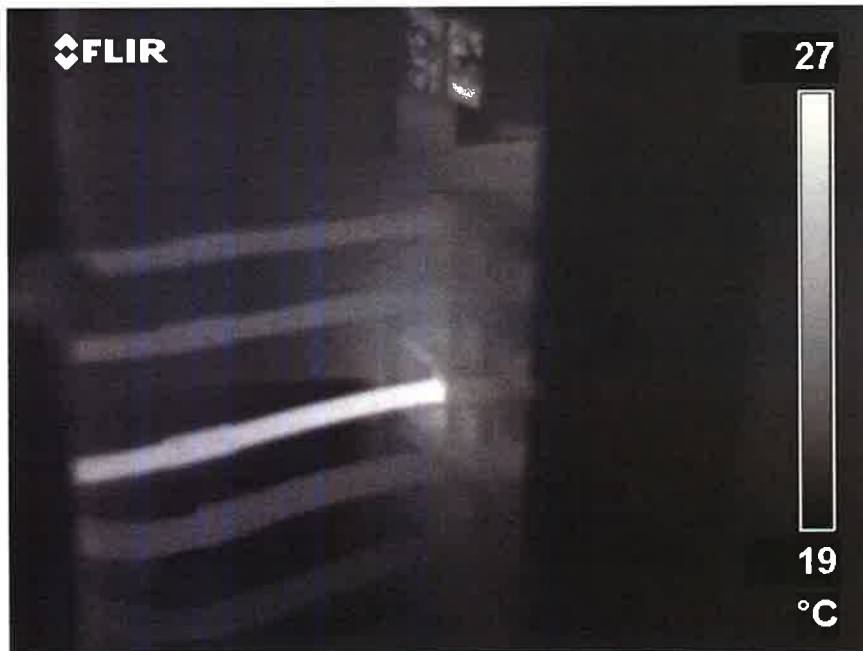
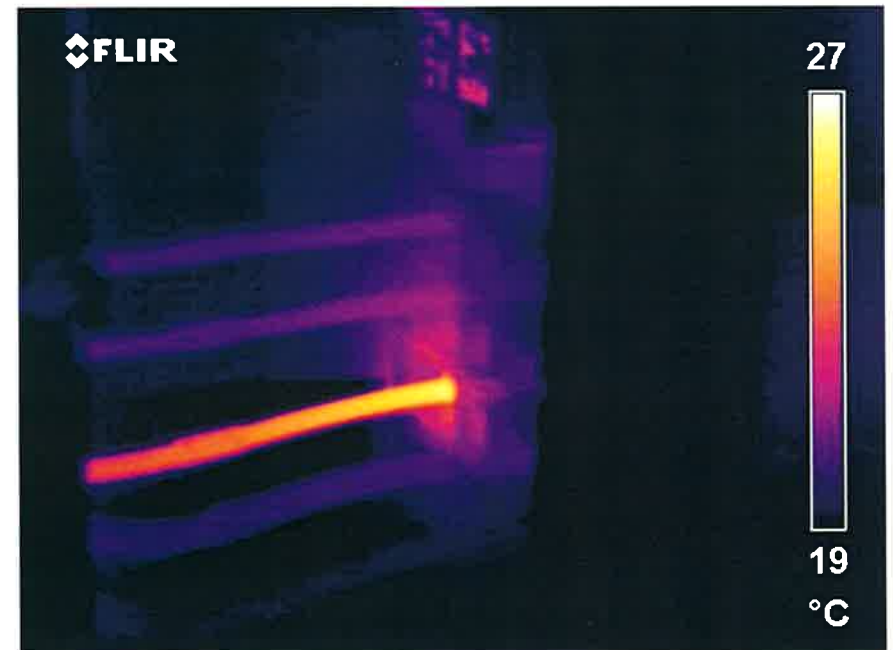
Area/Picture No. 5 Job No. 13-0000.00 Date 1/3/13

Ambient Temp 20°C 6 ° Rise Over Upper Connection

Comments Conductor Connection Temperatures:

Amps
Circuit 1	21°C	14.3
Circuit 3	22°C	10.2
Circuit 5	27°C	12.3

Priority 2

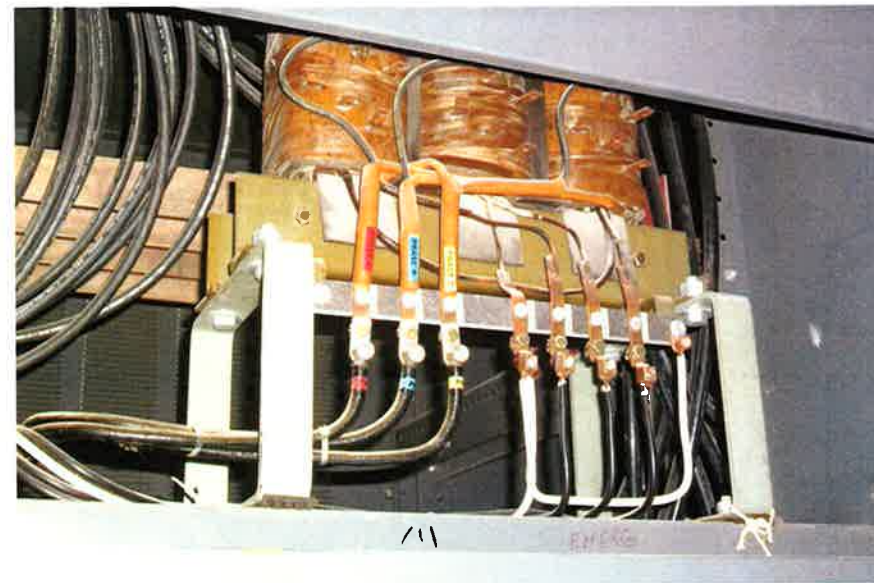
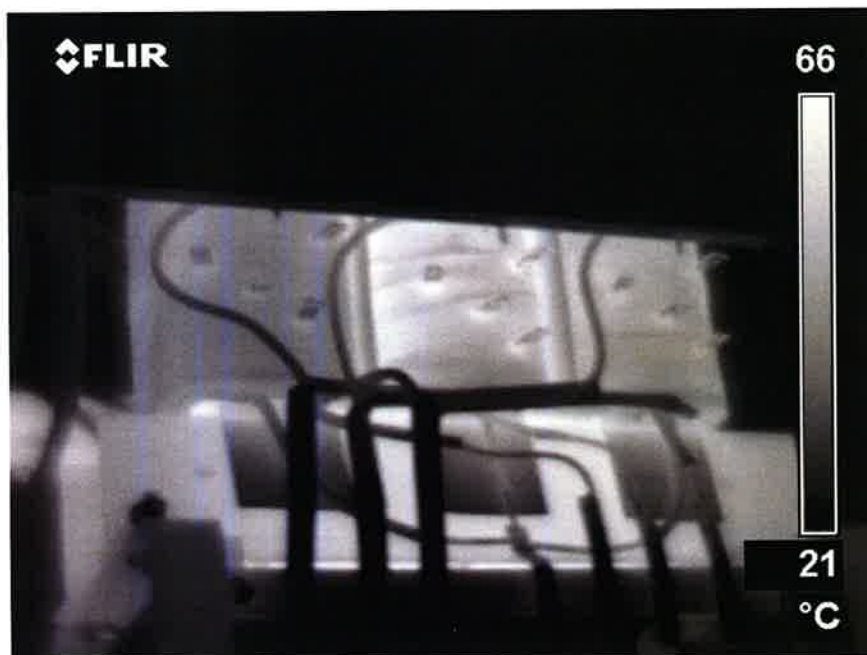
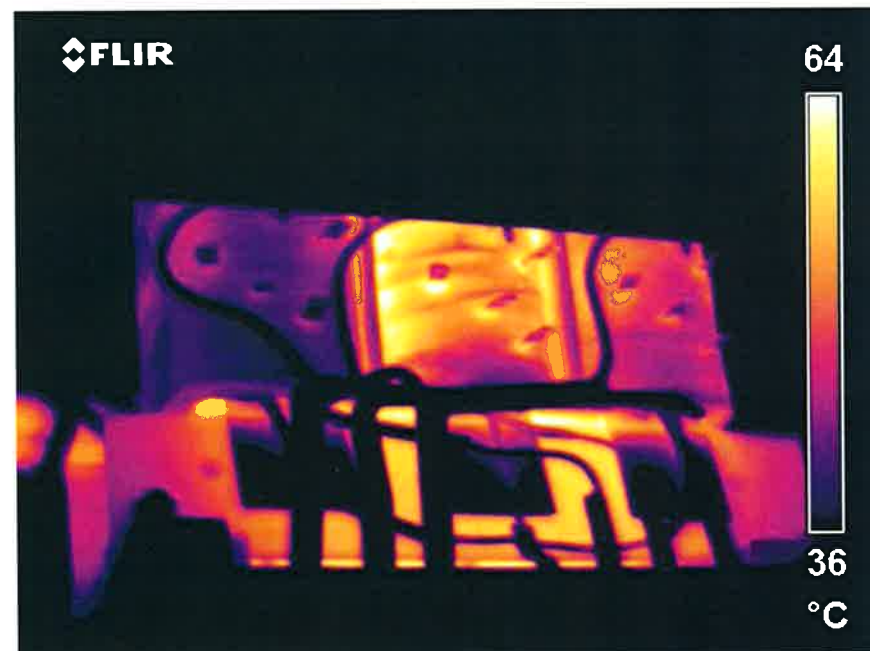
Area/Picture No. 6 Job No. 13-0000.00 Date 1/4/13

It should be noted that the problem described in picture number 6 has extremely high temperature differentials. This problem requires immediate attention.

Ambient Temp 13°C 16 ° Rise Over Left Winding

Comments Winding Temperatures:

Left	Middle	Right
40°C	56°C	45°C

Priority 1

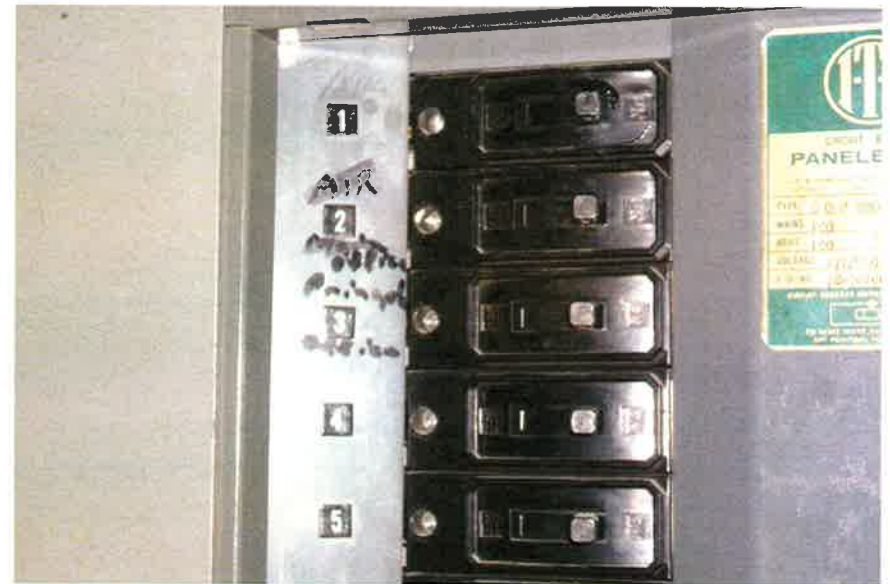
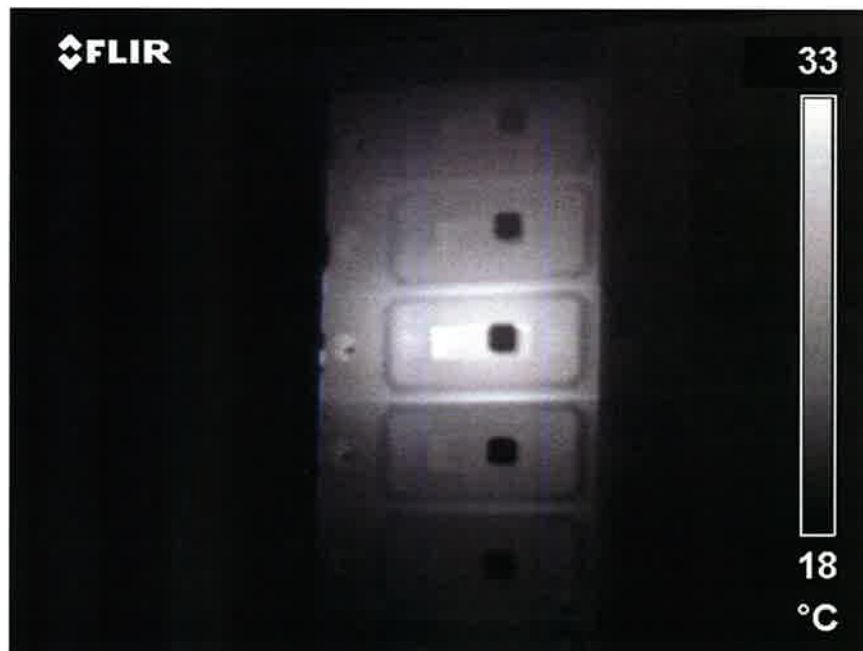
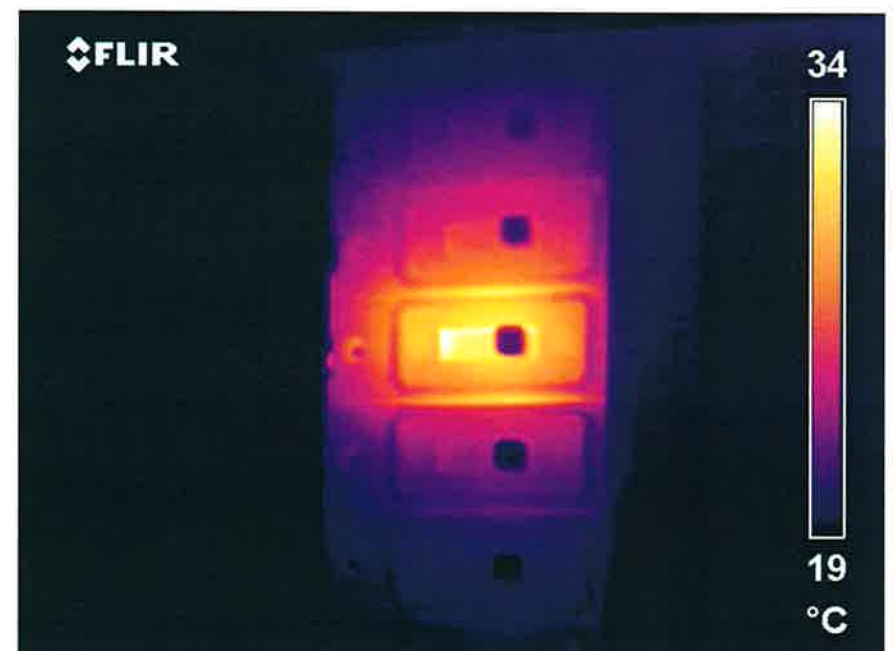
Area/Picture No. 7 Job No. 13-0000.00 Date 1/4/13

Ambient Temp 20°C 14 ° Rise Over Circuit Breaker 1

Comments Circuit Breaker Surface Temperatures:

Circuit Breaker 1 20°C

Circuit Breaker 3 34°C

Circuit Breaker 5 20°C

Priority 2

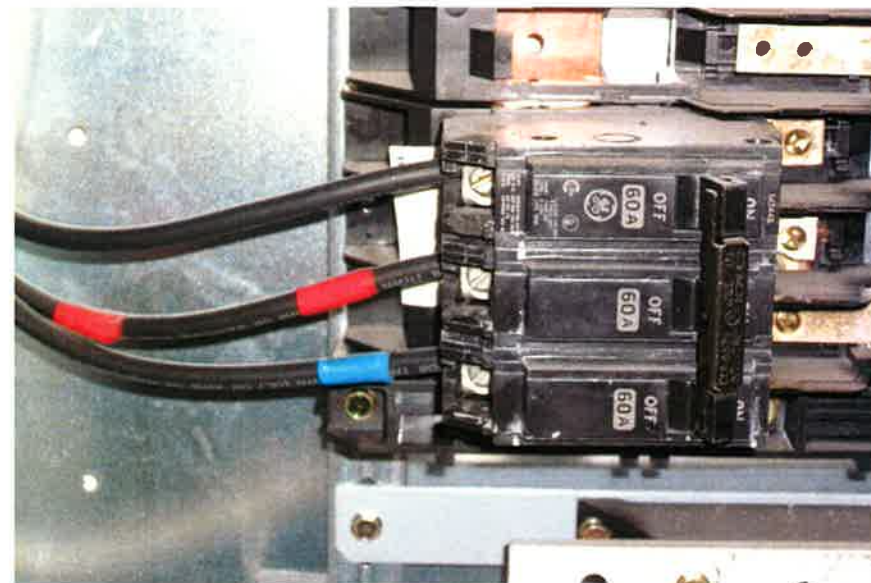
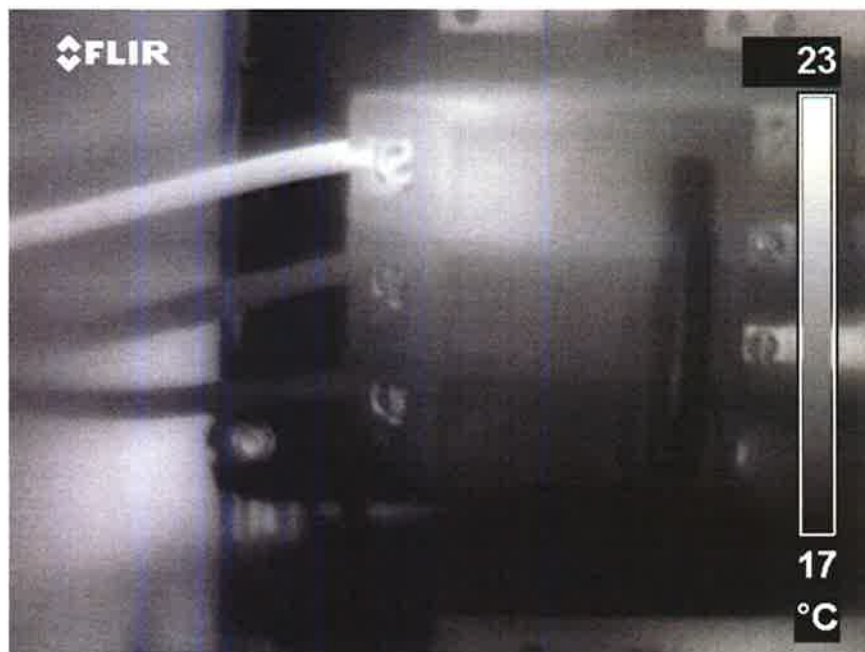
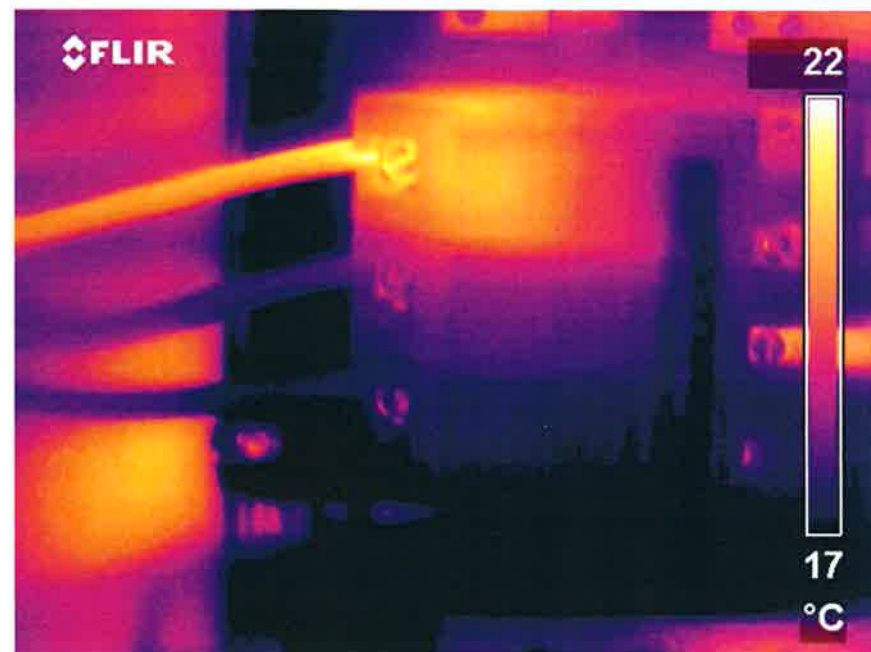
Area/Picture No. 8 Job No. 13-0000.00 Date 1/4/13
Location #3 Elementary School, Storage at Room 36
Equipment Power Panel, PP2, Main Circuit Breaker
Wind Speed N/A Wind From N/A Sky Indoor
Emiss. 1.00 B/G N/A° Distance 5' Lens 1x
Rated Load 60 Amps Measured Load 29 Amps % Load 48.33
Ambient Temp 20°C 5 ° Rise Over Lower Connection

Comments Conductor Connection Temperatures:

Amps
Upper	22°C	29
Middle	18°C	5.5
Lower	17°C	7.4

Priority 2
