**INFRARED ELECTRICAL SYSTEM SURVEY**

*ABC Shipping  
123 Main Street  
Anytown, USA*

*ABC Ship  
ABC Terminal  
Anytown, USA*

RE: INFRARED ELECTRICAL SYSTEM SURVEY REPORT  
OUR JOB NUMBER: 14-0000.00

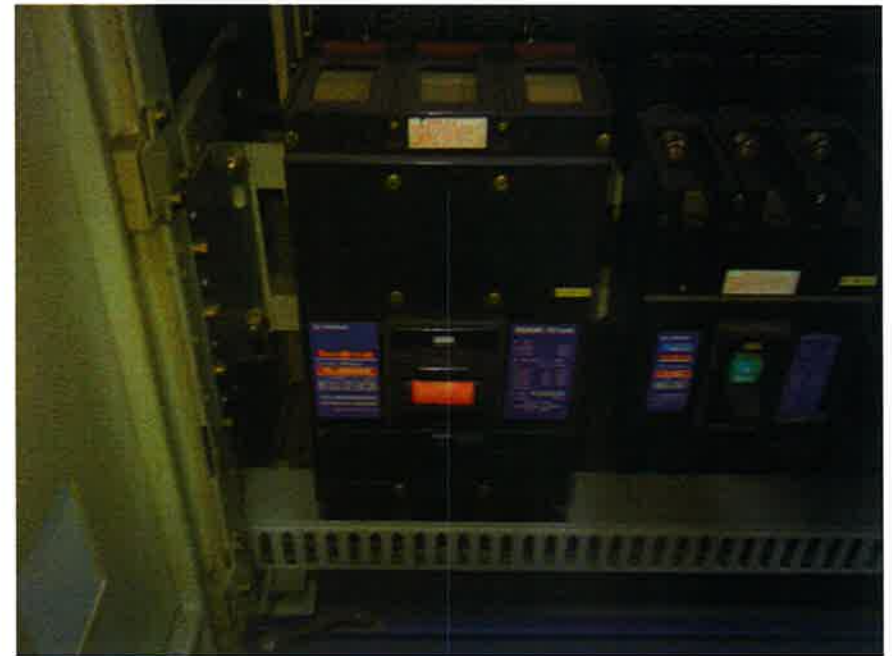
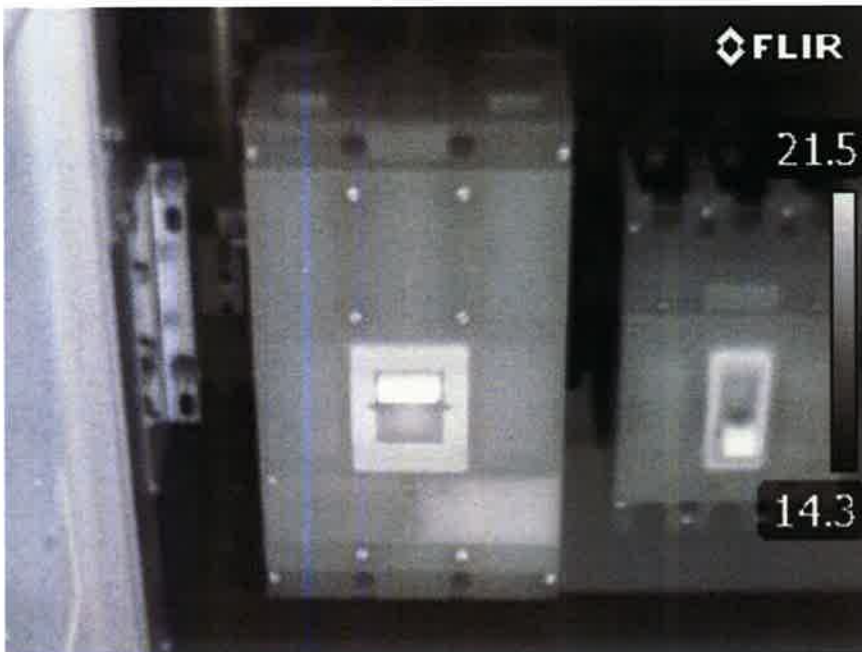
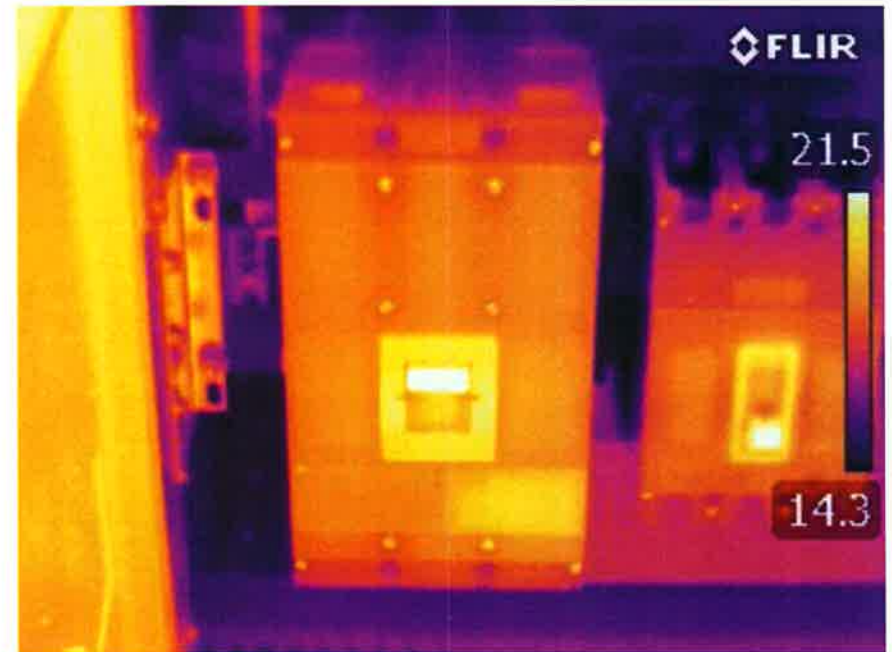
**Area/Picture No.** 1      **Job No.** 14-0000.00      **Date** 2/28/14  
**Location** Control Room  
**Equipment** SWBD, No. 1, 440V Feeder Panel  
**Wind Speed** N/A      **Wind From** N/A      **Sky** N/A  
**Emiss.** 1.00    **B/G** N/A°    **Distance** 5'      **Lens** 1x  
**Rated Load** N/A      **Measured Load** N/A      **% Load**  
**Ambient Temp** 22°C      **N/A ° Rise Over** N/A  
**Comments** Thermogram shows a normal thermal pattern.

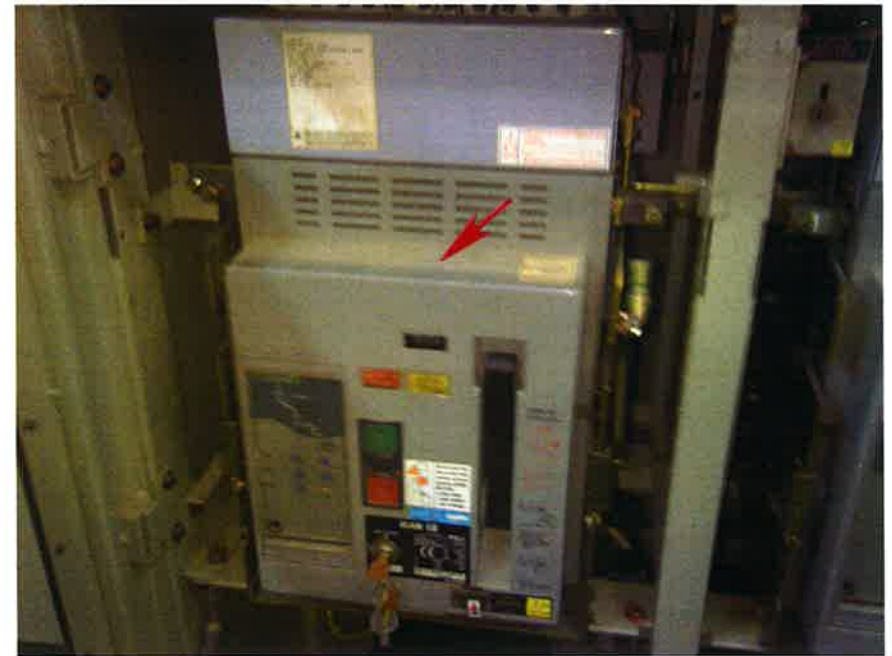
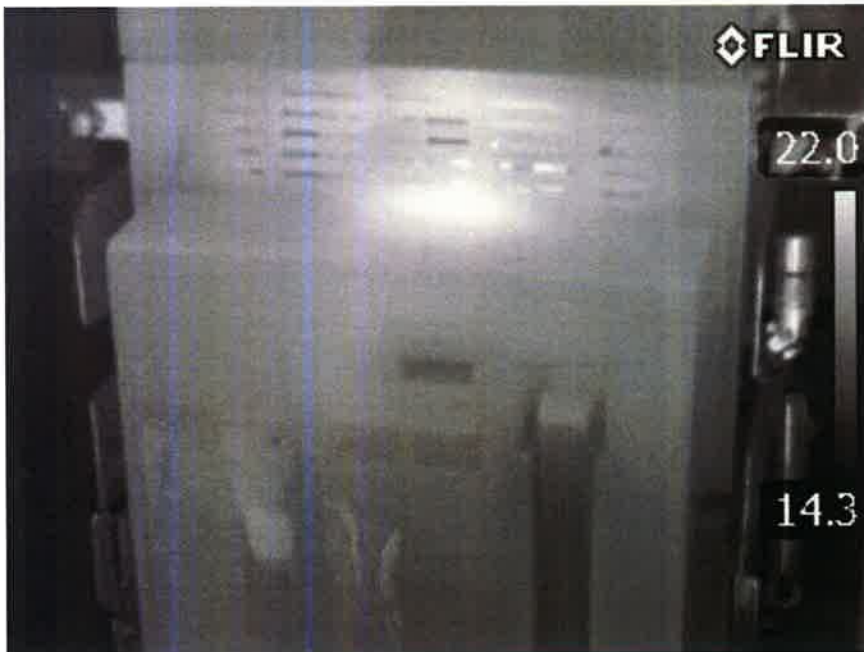
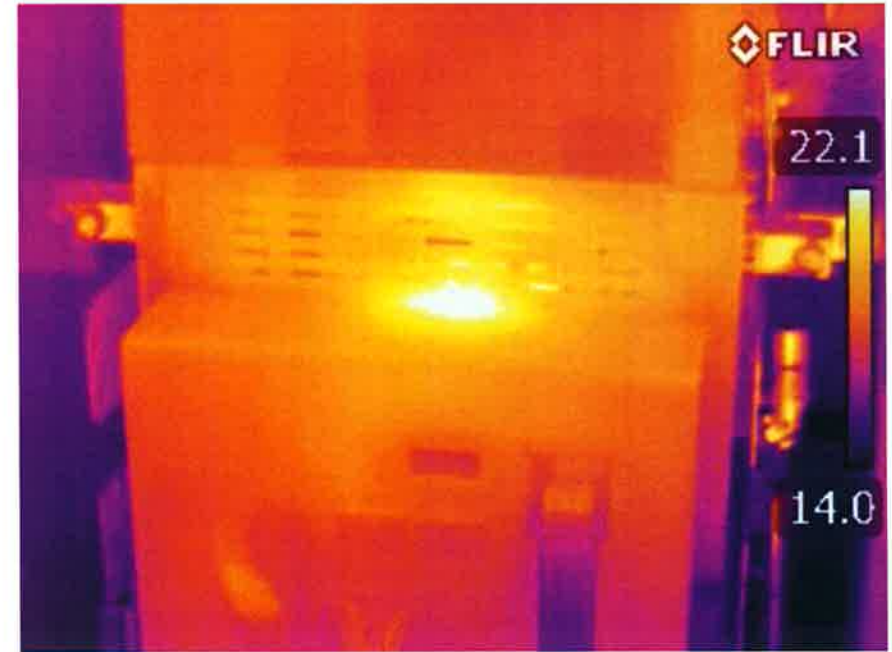
Area/Picture No. 2 Job No. 14-0000.00 Date 2/28/14

Equipment Emergency SWBD, Circuit Breaker, Main SWBD (Bus Tie)

Ambient Temp 16°C 8 ° Rise Over Ambient

Comments Circuit Breaker shows abnormal temperature on top.

Thermal Anomaly Temperature: 24°C

Priority 2

Note: Further investigation required.
