INFRARED FLAT ROOF MOISTURE SURVEY

*ABC Company
123 Main Street
Anytown, USA*

RE: INFRARED FLAT ROOF MOISTURE SURVEY REPORT
OUR JOB NUMBER: 12-2906.4

THERMOGRAPHER'S COMMENTS
OUR JOB NUMBER: 12-2906.4

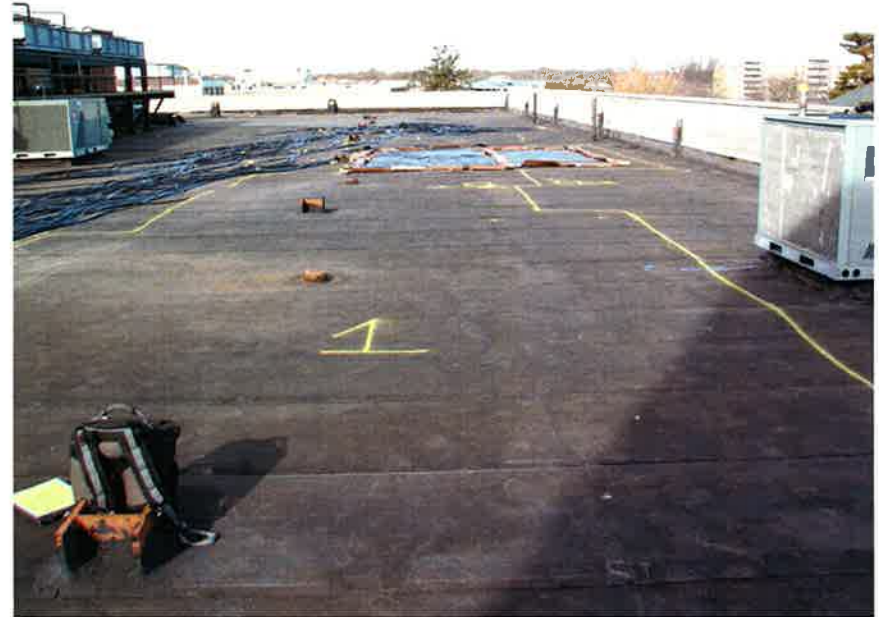
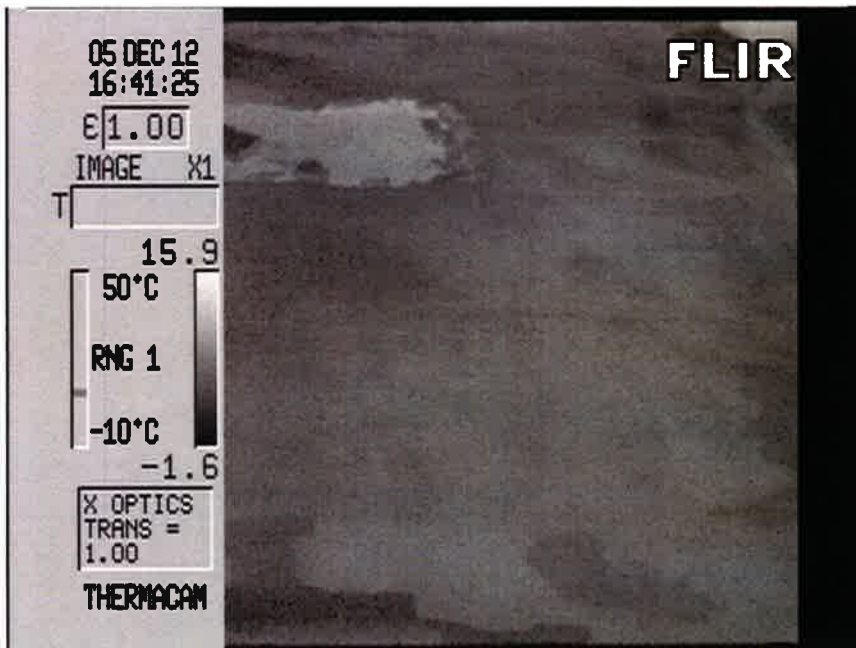
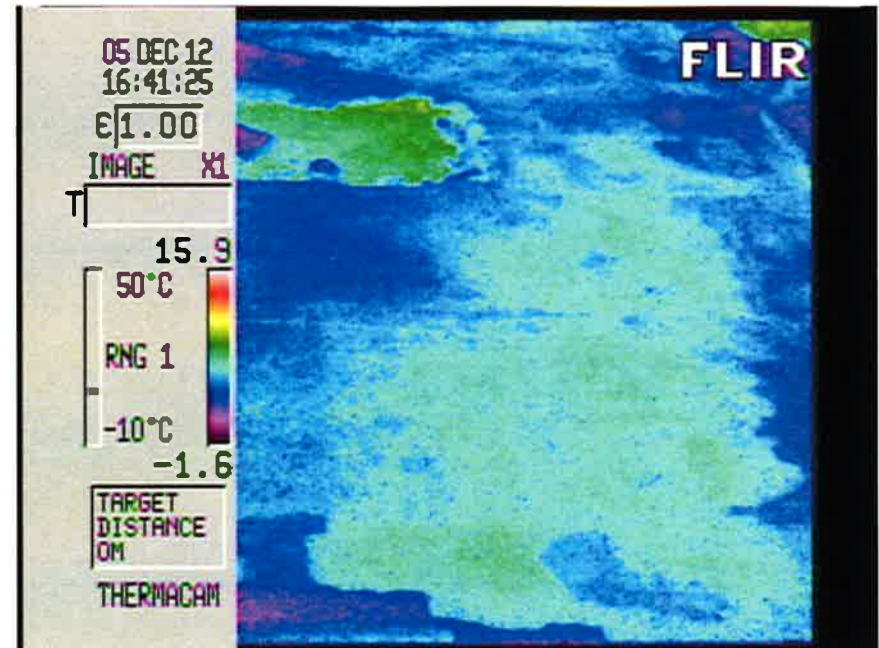
Area/Picture No 1 Job Number 12-2906.4 Date 12/5/12

FINDINGS: One area of moisture damage was found on the night of our Survey. Moisture probes confirmed the presence of moisture in the outlined area. The approximate percentage of moisture-damaged roof is as follows:

Ambient Temp 45 °F Location Section A

Damage Type Moisture

Overall size: 1,600 sq. ft. (apx.)

Previously patched: Yes

Blisters present: No

Moisture probe: Positive

Core sample: Positive*

Comments *3 Cores C-1 Pos.
C-2 Pos.
C-3 Neg.

RECOMMENDATIONS: We recommend that the moisture-damaged areas be ripped up and replaced. Should a decision be made to replace only the moisture-damaged areas, an area at least one foot wider than the painted outlines should be replaced to ensure that all moisture damage is removed. Since some of the areas may enlarge by the time repairs are made, the roofer should remove all moisture damage found.

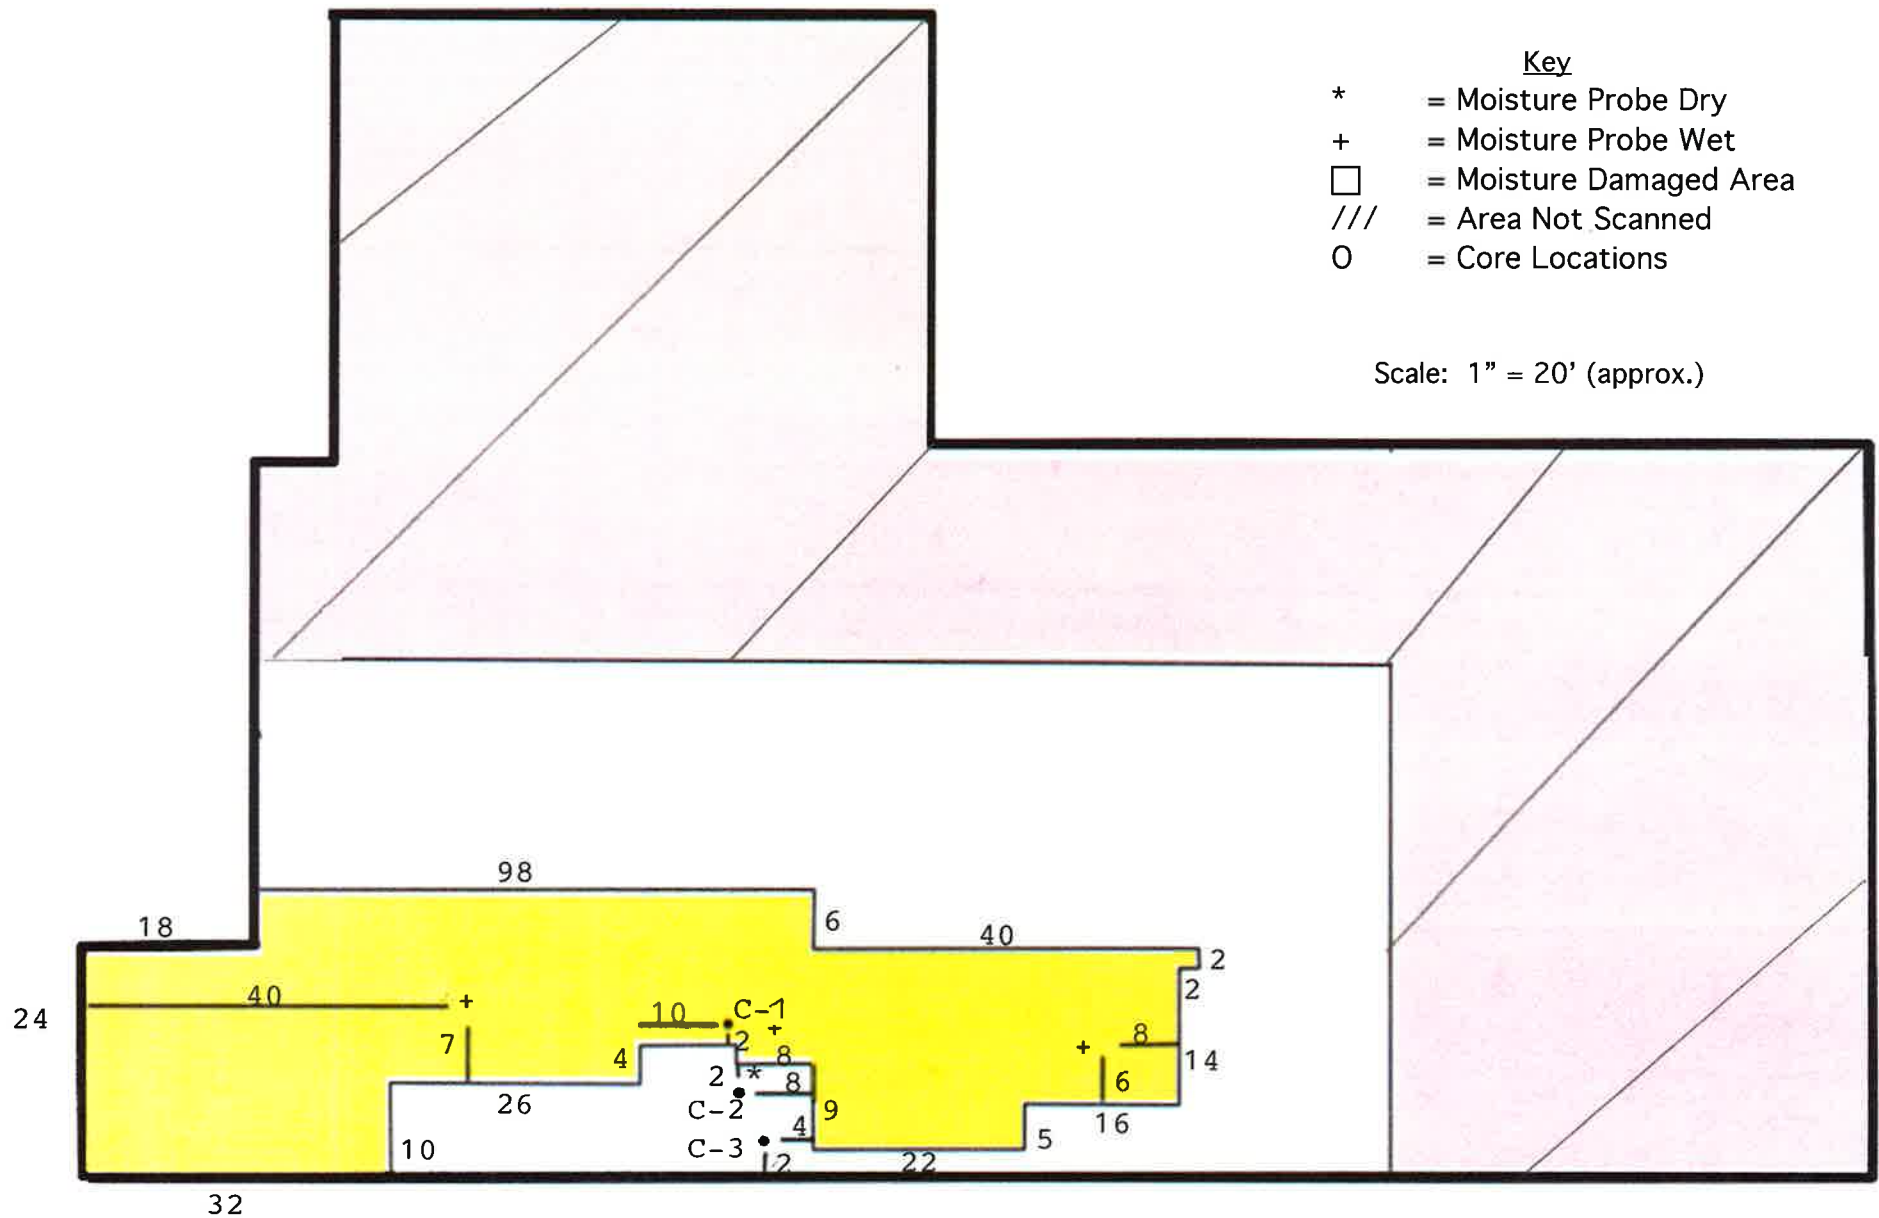
This report contains a scaled map of the roof with the moisture-damaged areas marked in yellow. These yellow areas correspond to the areas of the roofing system which contain moisture. All moisture-damaged areas of the roof are outlined with yellow spray paint on the roof surface. Also included in this report are Thermograms and control photographs of the moisture-damaged areas.
