ELECTRICAL RECEPTACLE TESTING SURVEY

Any Facility
123 Main Avenue
Anytown, NJ 07306

JERSEY INFRARED CONSULTANTS

RE: ELECTRICAL RECEPTACLE TESTING
SURVEY REPORT OUR JOB NUMBER: 20-1722.39

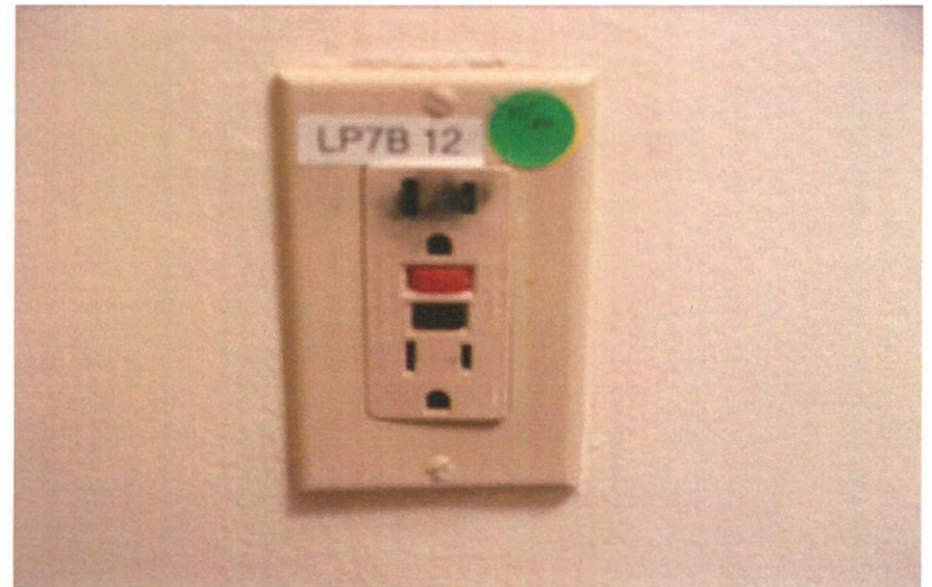
Area/Picture No. 1 **Job No.** 20-1722.39 **Date** 11/23/2020

Comments Damaged outlet, discolored outlet.

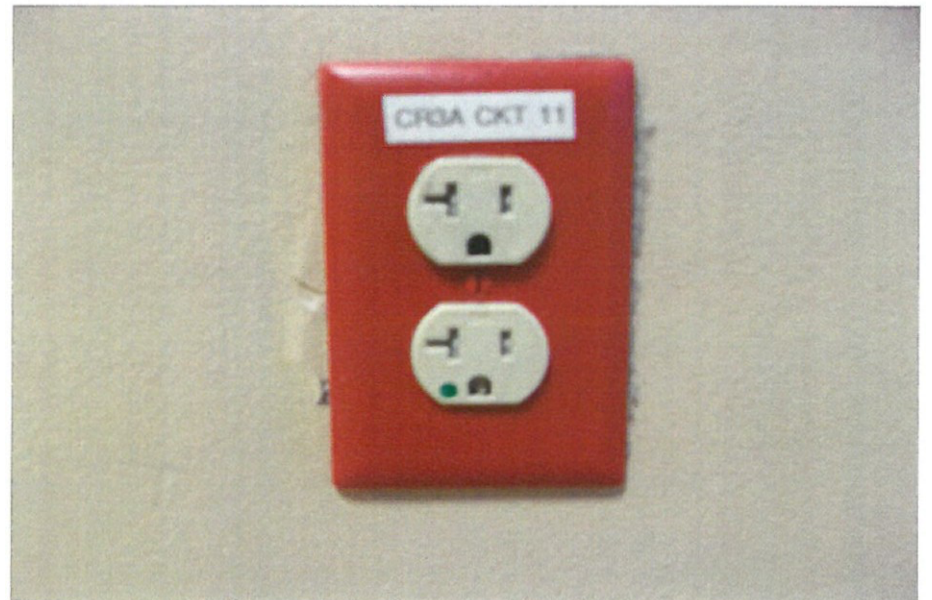
Area/Picture No. 2 **Job No.** 20-1722.39 **Date** 11/23/2020

Comments Broken ground prong, bottom receptacle.

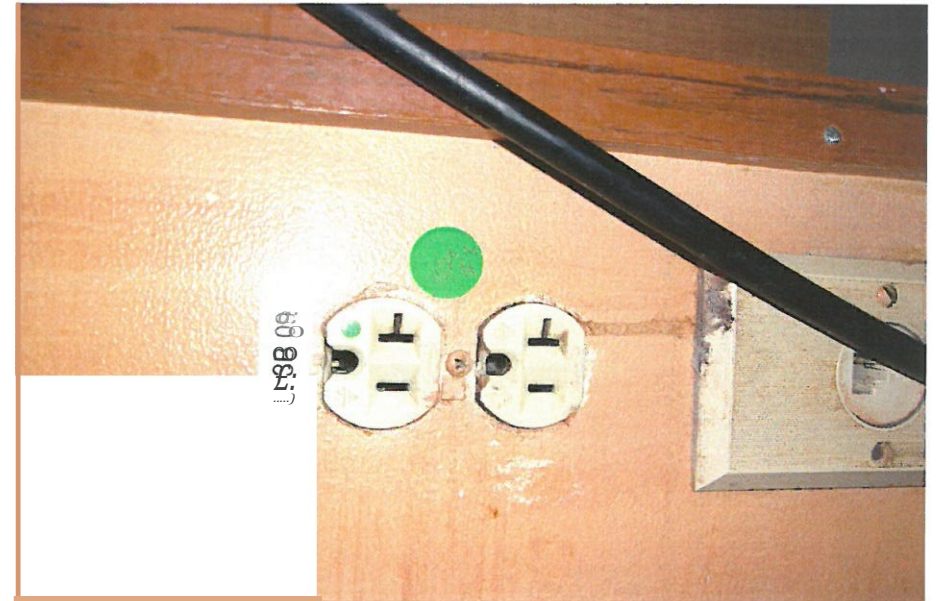
Area/Picture No. 3 **Job No.** 20-1722.39 **Date** 11/23/2020

Comments Visual fault face plate on grounds are broken.

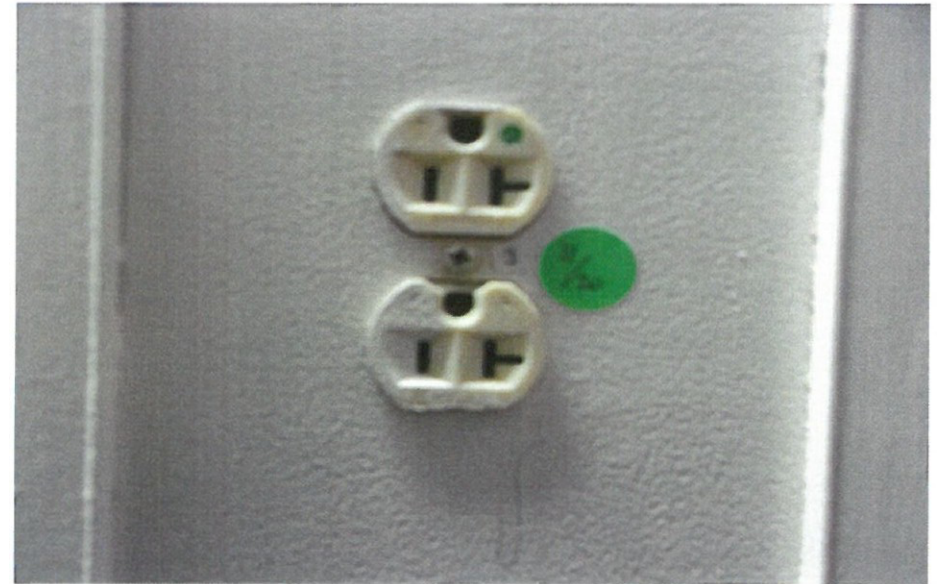
Area/Picture No. 5 **Job No.** 20-1722.39 **Date** 11/25/2020

Comments Broken face plate.

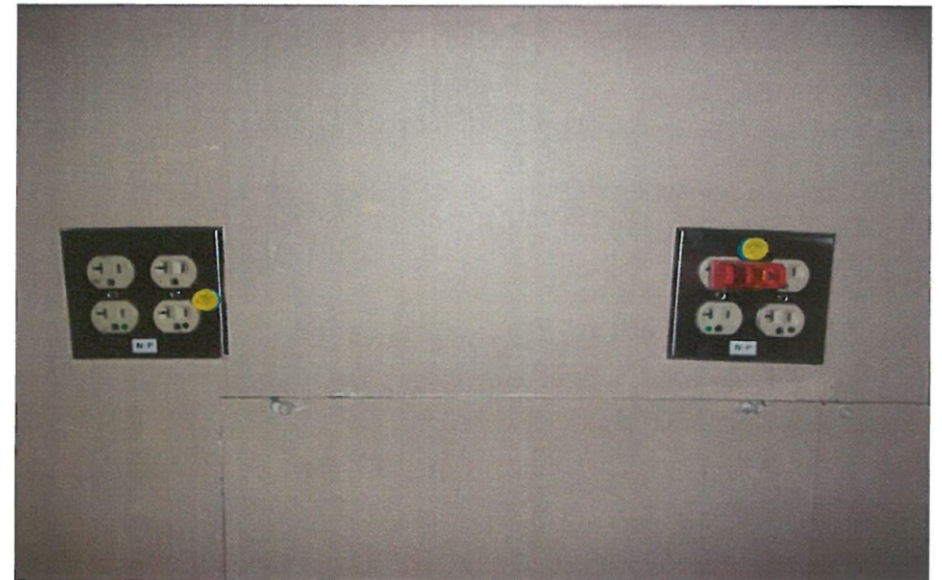
Area/Picture No. 6 **Job No.** 20-1722.39 **Date** 11/30/2020

Comments Both quad receptacles under desk, open hot.
Left of Primus room.
